# BUILDING IDENTIFICATION FORM

RICHMOND CONSERVATION STUDY

BUILDING ADDRESS **17-1A ERIN ST**

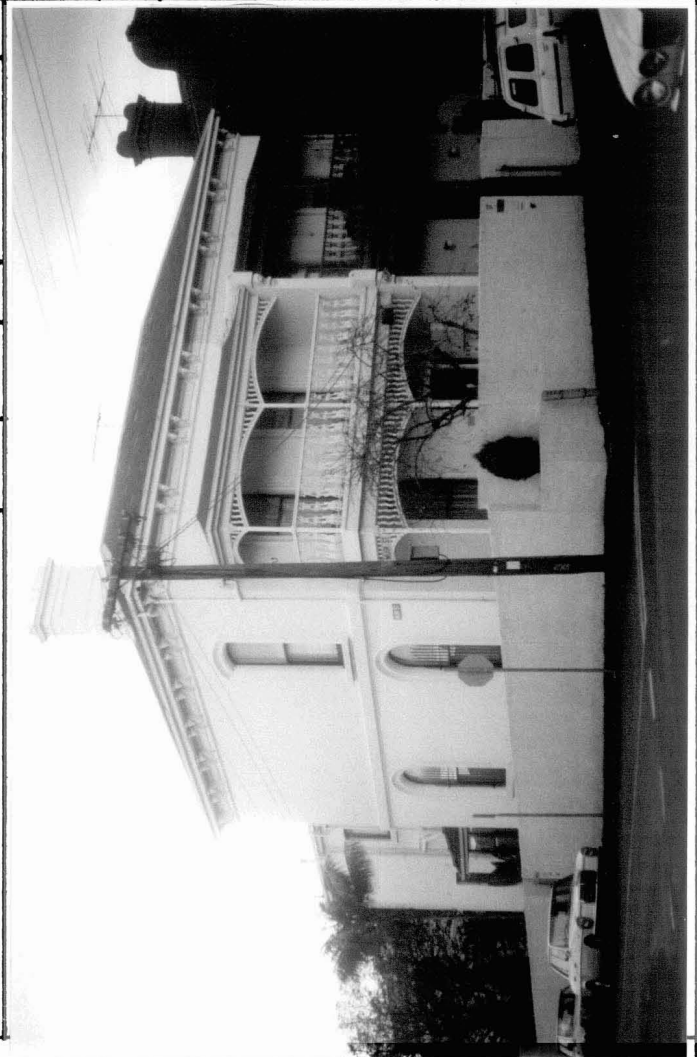
Walls **CEMENT RENDER** Roof **SLATE**

**Semi**  
Detached

intact verandah decoration **(17?)**

original chimneys **(17)**

**PAIR OF 1870'S SEMI-DETACHED HOUSES UNUSUAL IN THAT THEY HAVE A PARAPET-LESS FACADE. INTEGRITY IS SPOILT BY THE LOSS OF THE ORIGINAL CAST IRON FRIESES.**

No.	Sympathetic	S.G.	Inappropriate	S.G.	Extremely Inappropriate	S.G.
<b>17, 19</b>					<b>FENCE</b>	<b>O/S</b>
<b>1A</b>					<b>MISSING IRON</b>	<b>O</b>
