# BUILDING IDENTIFICATION FORM 167

RICHMOND CONSERVATION STUDY

BUILDING ADDRESS 62 & 64 GREEN ST.

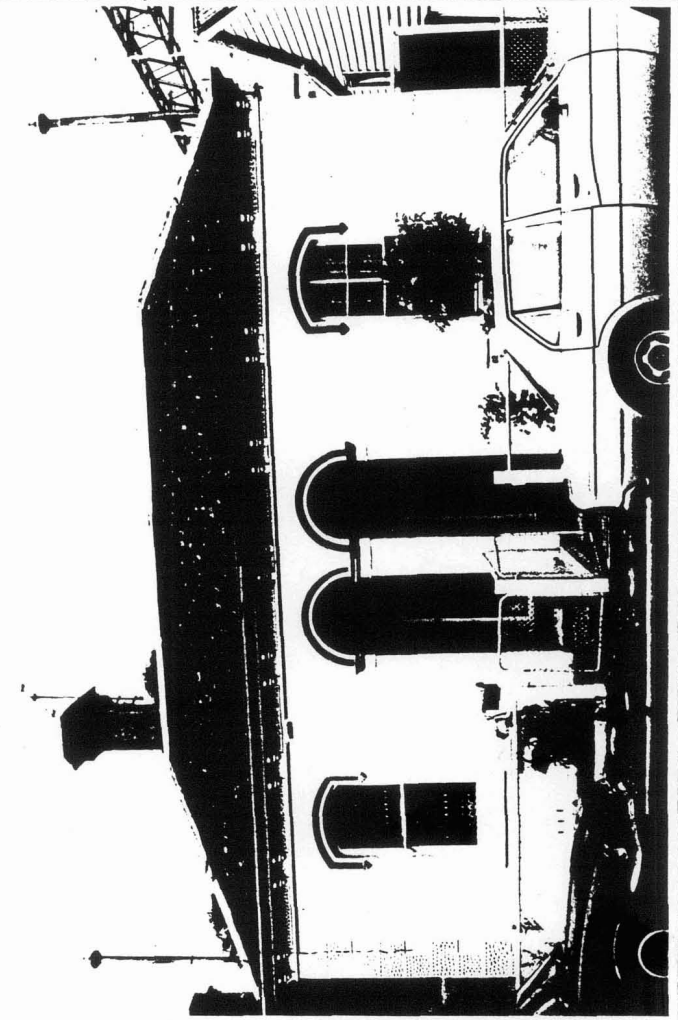
early paint colour scheme <input type="checkbox"/>	eaves, <del>roof or</del> <u>gable</u> decoration <input checked="" type="checkbox"/>
original unpainted wall finish <input type="checkbox"/>	intact verandah decoration <input type="checkbox"/>
ornamental wall detailing <input checked="" type="checkbox"/>	early fence <input type="checkbox"/>
original <del>verandah</del> window <u>62</u> <input checked="" type="checkbox"/>	early garden <input type="checkbox"/>
intact verandah structure <input type="checkbox"/>	other prominent contrib. elevations <input type="checkbox"/>
original parapet <input type="checkbox"/>	<u>BATT BAND &amp; BRICK ON EDGE WALLS</u> <input checked="" type="checkbox"/>
original roof form & finish <input checked="" type="checkbox"/>	<input type="checkbox"/>
original chimneys <u>64</u> <input checked="" type="checkbox"/>	<input type="checkbox"/>

INTEGRITY RATING excellent  good  fair  poor

COMMENTS ATTRACTIVE PAIR OF SEMI-DETACHED ITALIANATE COTTAGES (LATE 1860'S) WITH DECORATIVE HOOD MOULDS, RECESSED ENTRANCE DOORS & VERMICULATED QUOINS. & RARE BRICK ON EDGE WALLS.

No.	Sympathetic	S.G.	Inappropriate	S.G.	Extremely Inappropriate	S.G.
	<u>FENCES.</u>					
<u>64</u>			<u>DOOR</u> <u>PAINTED RENDER.</u>

O = reinstate original designs    S = reinstate sympathetic alternative    R = remove    RAM = Remove by approved method
