BUILDING IDENTIFICATION FORM

RICHMOND CONSERVATION STUDY

BUILDING ADDRESS *10 MUIR ST.*

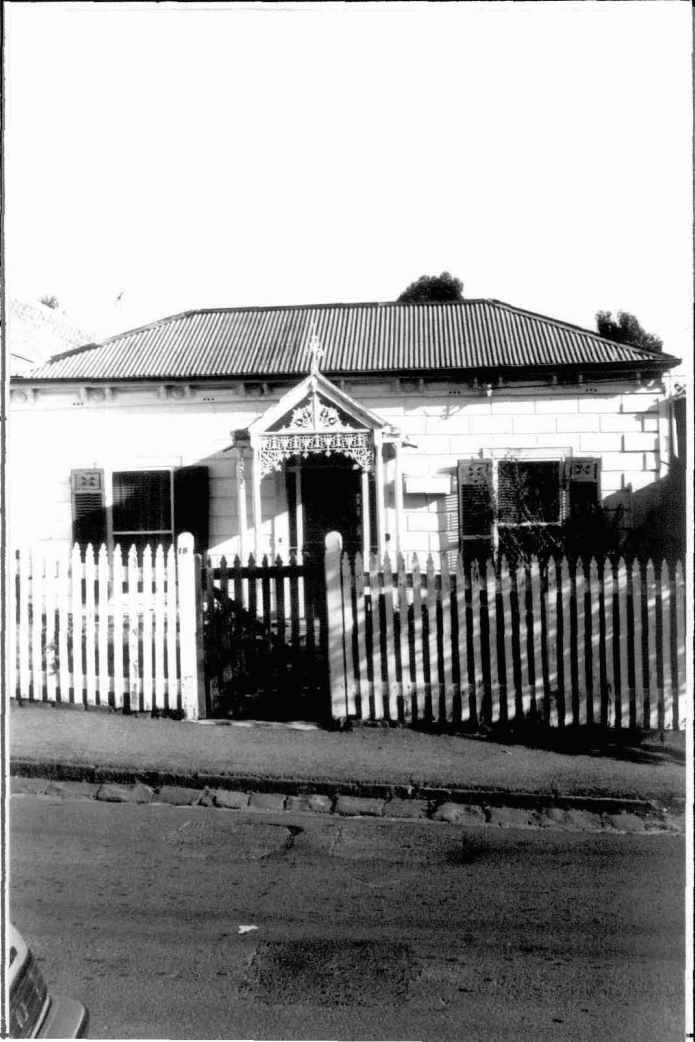
Only example in study area of cast iron portico/verandah. The verandah is elaborately detailed and is flanked by early shutters with unusual fretwork panels. The timber picket fence is also a rare survivor.
