BUILDING IDENTIFICATION FORM

RICHMOND CONSERVATION STUDY

BUILDING ADDRESS *5 MULBERRY ST.*

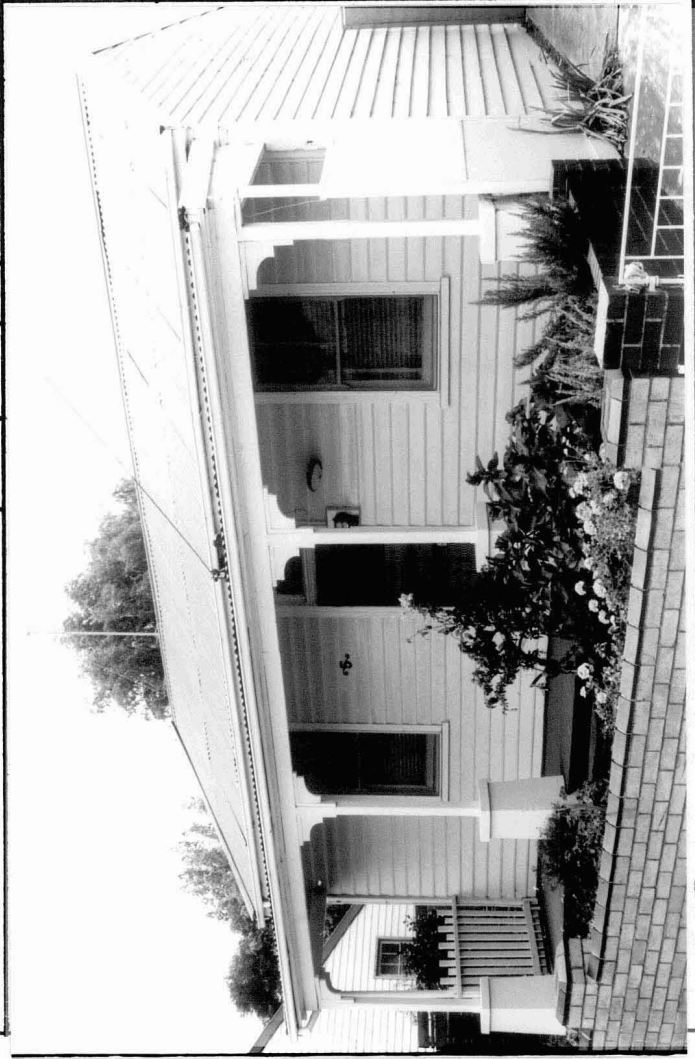
Walls *WEATHERBOARD* Roof *IRON*

No.	Sympathetic	S.G.	Inappropriate	S.G.	Extremely Inappropriate	S.G.
			<i>VERANDAH POSTS</i>	<i>S</i>		
			<i>VERANDAH BRACKETS</i>	<i>S</i>		
			<i>FENCE</i>	<i>S</i>		
			<i>DOOR</i>	<i>O</i>		
			<i>BOTTOM WINDOW SASHES</i>	<i>O</i>

REMNANTS OF TIMBER FILASTERS ON FACADE INDICATE 1860'S. DVOLO EDGED WEATHERBOARDS INTERESTING.

O = reinstate original designs

S = reinstate sympathetic alternative
