CITY OF GEELONG WEST

URBAN CONSERVATION STUDY: BUILDING IDENTIFICATION FORM

BUILDING ADDRESS **53 Weller Street**

URBAN CONSERVATION STUDY BUILDING IDENTIFICATION FORM

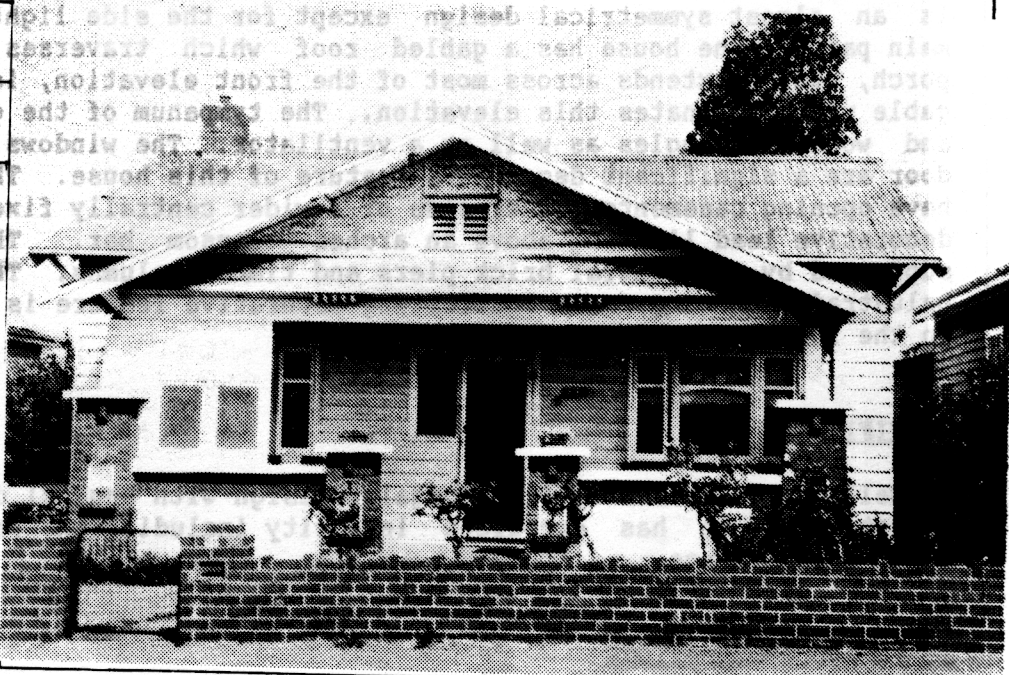
53 Weller Street is a beautifully intact example of a modest Bungalow. It is similar to known State Savings Bank houses of the period. It is a single storey house clad in weatherboards. The roof is gabled with corrugated iron cladding. It is an almost symmetrical design except for the side light by the front door. The main part of the house has a gabled roof which traverses the site. A central porch, which extends across most of the front elevation, is formed by a projecting gable which dominates this elevation. The tympanum of the gable has pressed metal and wooden shingles as well as a ventilator. The windows either side of the front door are a significant decorative feature of this house. They are in threes and have opening casements either side of a wider centrally fixed window light which has decorative lead lighting above an arched transom bar. The projecting gable is supported by substantial brick piers and timber columns. These are reflected in the balustrade and fence. An interesting decorative feature is the use of small niches in the four brick piers of the balustrade.

53 Weller Street is a typical Bungalow design with unusual decorative niches in the balustrade. It has excellent integrity including the fence and gate. It is of local significance.

Removal of the verandah infill and painting the timber an appropriate colour would greatly enhance the character of this building.
