BUILDING IDENTIFICATION FORM

RICHMOND CONSERVATION STUDY

BUILDING ADDRESS 3 Portland Street

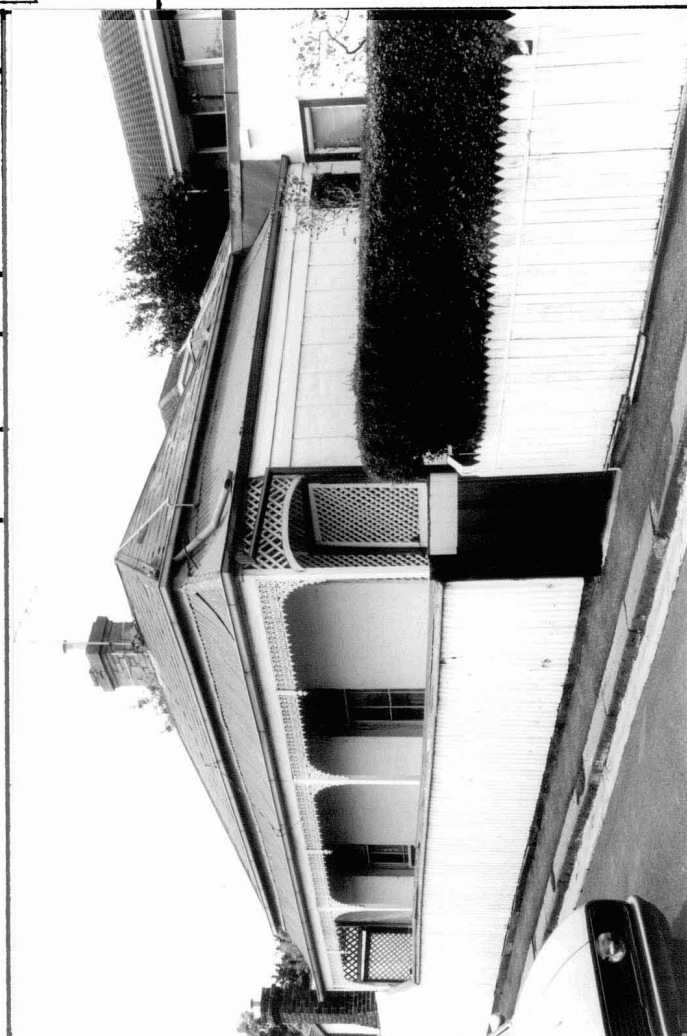
Walls Ruled Render Roof Slate

early paint colour scheme	<input type="checkbox"/>	eaves, roof or gable decoration	<input type="checkbox"/>
original unpainted wall finish	<input type="checkbox"/>	intact verandah decoration	<input checked="" type="checkbox"/>
ornamental wall detailing	<input checked="" type="checkbox"/>	early Picket Fence	<input checked="" type="checkbox"/>
original doors/windows	<input checked="" type="checkbox"/>	early garden	<input type="checkbox"/>
intact verandah structure	<input type="checkbox"/>	other prominent contrib. elevations	<input checked="" type="checkbox"/>
original parapet	<input type="checkbox"/>		<input type="checkbox"/>
original roof form & finish	<input checked="" type="checkbox"/>		<input type="checkbox"/>
original chimneys	<input checked="" type="checkbox"/>		<input type="checkbox"/>

No.	Sympathetic	S.G.	Inappropriate	S.G.	Extremely Inappropriate	S.G.
	Ver. Posts		Ver. Infill	R		
			Side Additions	R		
			Corr. Iron Balustrade	S

COMMENTS Cast iron is late Victorian. Asbestos cement outhouse is built around early kitchen chimneys.

O = reinstate original designs S = reinstate sympathetic alternative R = remove RAM = Remove by approved method
