BUILDING IDENTIFICATION FORM

RICHMOND CONSERVATION STUDY

BUILDING ADDRESS *50 - 48 ROTHERWOOD ST.*

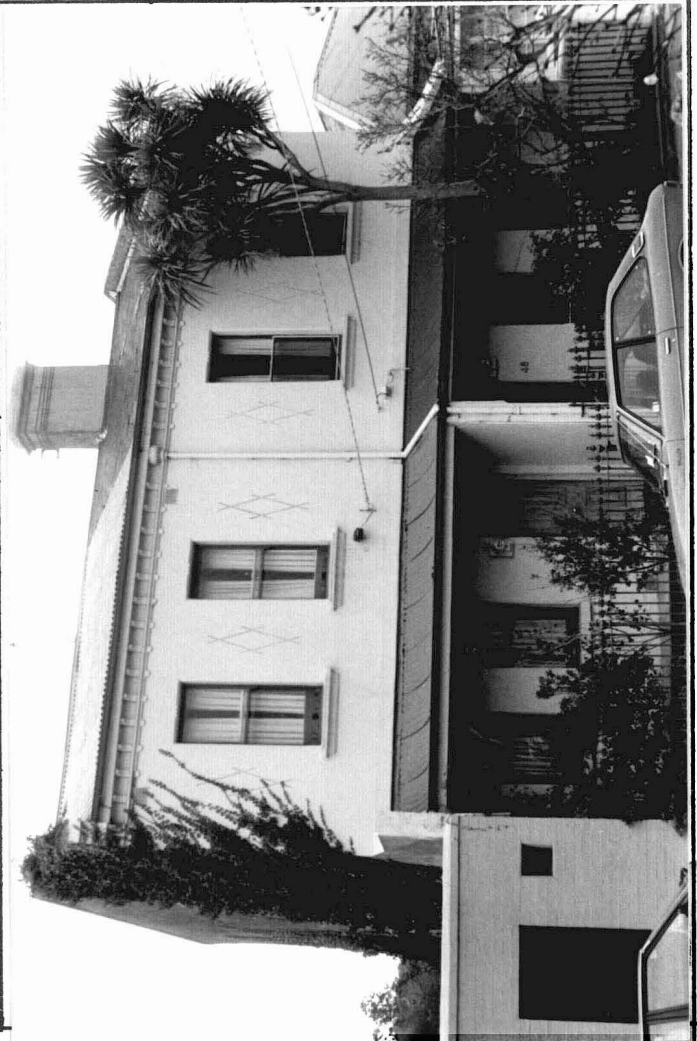
No.	Sympathetic	S.G.	Inappropriate	S.G.	Extremely Inappropriate	S.G.
<i>50</i>	<i>IRON ROOF</i>	<i>O</i>				
<i>50</i>			<i>VERANDAH PARAPET</i>	<i>O</i>

Substantially intact Victorian, rendered brick pair of terrace houses with well detailed cornice, simple incised render patterns and iron palisade fence

O = reinstate original designs
