Building:	House	Significance:	B
Address:	14 Abinger Street, Richmond	Melway Map Ref:	2H A7
Building Type:	Residence	Construction Date:	c.1870s?
Architect:	Unknown	Builder:	Unknown

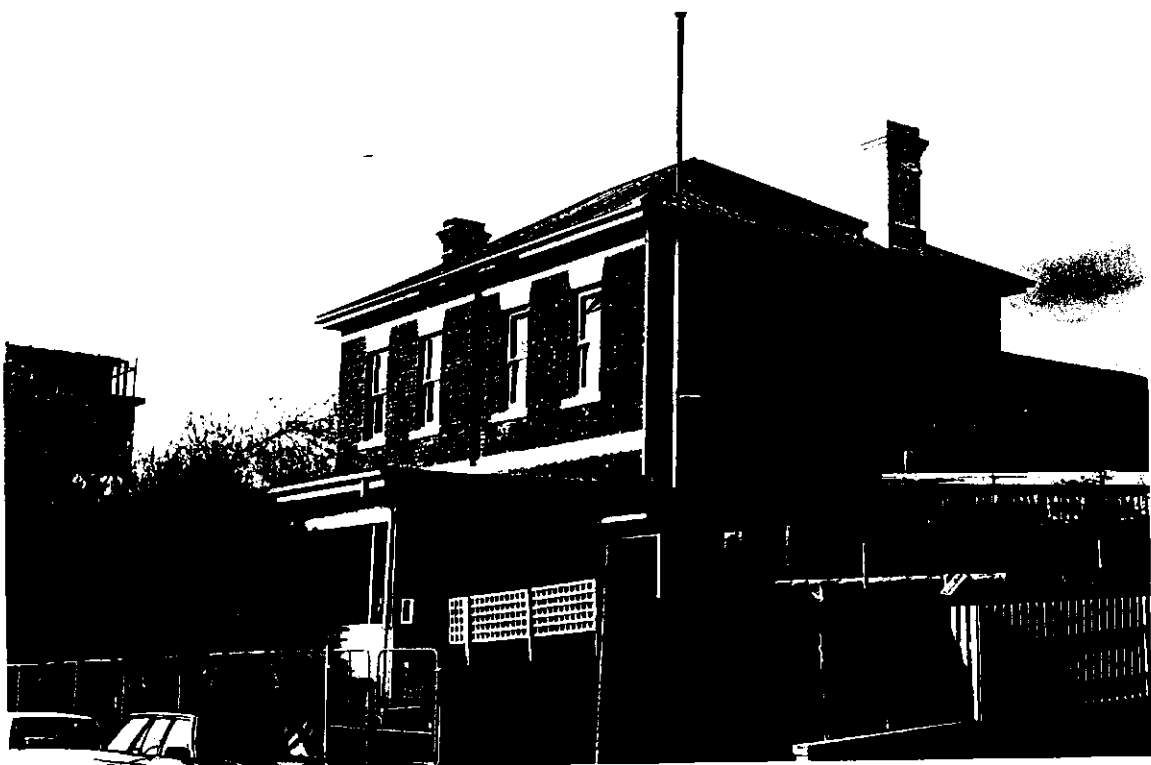
The house at 14 Abinger Street is a large double-storey red brick building, with a hipped slate roof. The house has a wide frontage and is set back from the street. The symmetrical street elevation has four double-hung sash windows at first floor level, with rendered sills and voussoirs. A moulded rendered string course runs across the elevation beneath the eaves. A relatively recent single-storey brick and weatherboard addition has been constructed in the front garden, obscuring the original ground floor elevation. Chimneys are red brick, with corbelled caps; the west chimney has been painted.

The house at 14 Abinger Street, Richmond, is of local architectural significance. The house is a simple and restrained example of a late 19th century villa and is a prominent element in the streetscape. The appearance of the house is marred by the obtrusive ground floor extension.
