Building:	Terrace	Significance:	B
Address:	3-7 Derby Street, Collingwood	Melway Map Ref:	2C D12
Building Type:	Residences	Construction Date:	1876
Architect:	Unknown	Builder:	Unknown

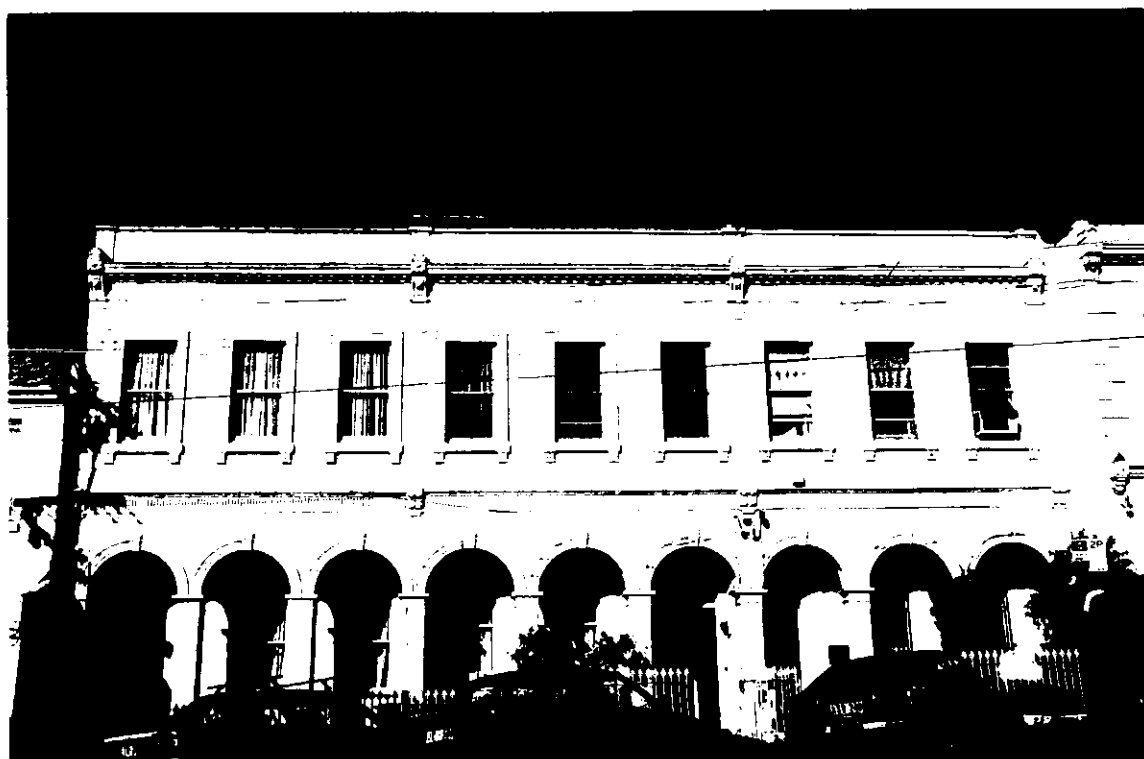
Intactness:		Condition:	
G[x] F[] P[]		G[x] F[] P[]	
Existing Heritage Listings:		Recommended Heritage Listings:	
Victorian Heritage Register	[]	Victorian Heritage Register	[]
Register of the National Estate	[]	Register of the National Estate	[x]
National Trust	[]	Heritage Overlay Controls	[x]

The terrace at 3-7 Derby Street, Collingwood, is a row of three attached double storey rendered brick houses, attached to Derby House at No. 1. The ground floors each have three-bay arcaded loggias, with moulded heads and keystones. The first floors each comprise three single windows with rendered moulded architraves and bracketed sills. There is a dentillated moulded string course at first floor level, and the first floor has quoined panels dividing each dwelling's facade. The parapet has a moulded cornice. The windows are timber-framed double-hung sashes.

The original front fences have been retained.
