Building:	Terrace	Significance:	B
Address:	47-55 Grant Street, Clifton Hill	Melway Map Ref:	2C K1
Building Type:	Residences; Shops	Construction Date:	1886-87
Architect:	Unknown	Builder:	Unknown

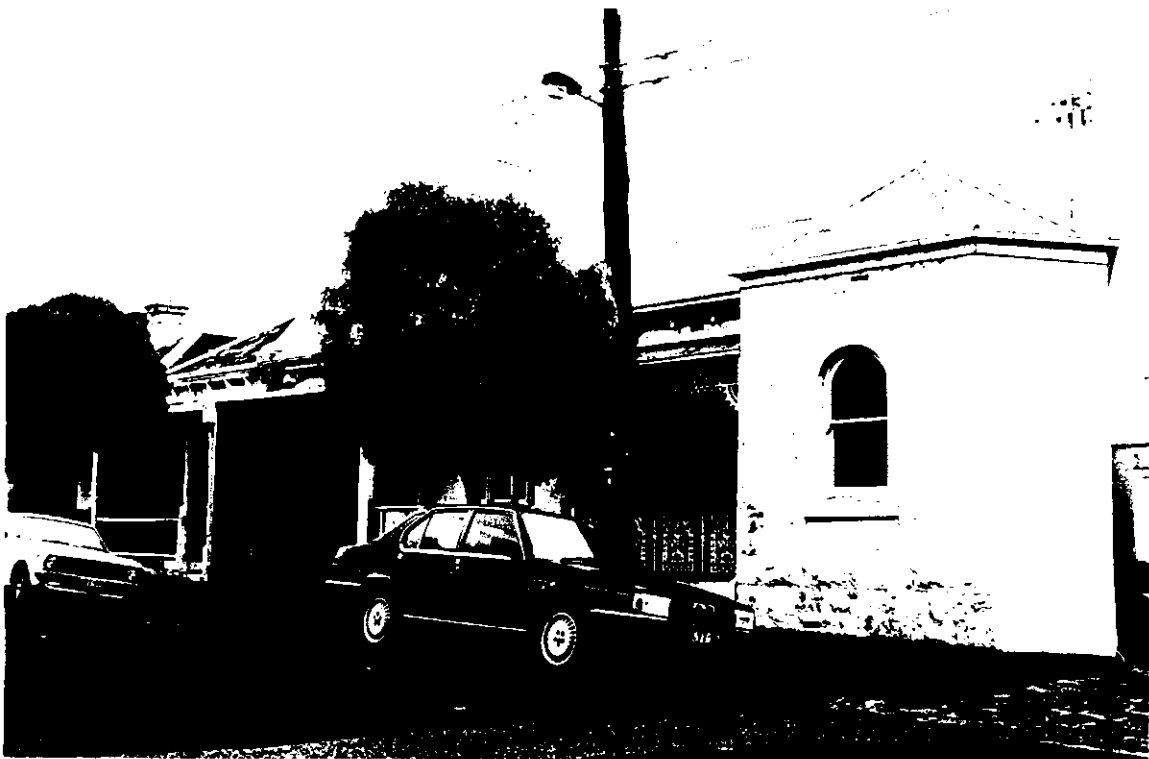
The terrace at 47-55 Grant Street, comprises 5 single-storey brick houses. Each house has a skillion-roofed corrugated iron verandah, supported on timber posts, separated by brick wing walls. The ends of the wing walls are decorated with corbelled vermiculated panels, and the ends of the party walls between the roofs have classical masks. Windows are tripartite double-hung sashes. The house at No. 55 has an unusual projecting section built to the street alignment, with an angled corner and a single semi-circular arched double-hung sash window. Roofs are hipped, with bracketed eaves. The chimneys are rendered, with moulded caps.

Most of the original cast iron work has been removed; original cast iron friezes survive at No. 48 and 49. Only Nos. 49 and 51 retain the original slate roofs; the remainder have been reclad in corrugated galvanised steel. All of the brickwork has been painted, and none of the original front fences survive. Some of the original windows have been replaced, and some of the chimneys have been removed.
