Building:	Terrace	Significance:	B
Address:	151-153 Langridge Street, Collingwood	Melway Map Ref:	2C G12
Building Type:	Residences	Construction Date:	1884
Architect:	Unknown	Builder:	Unknown

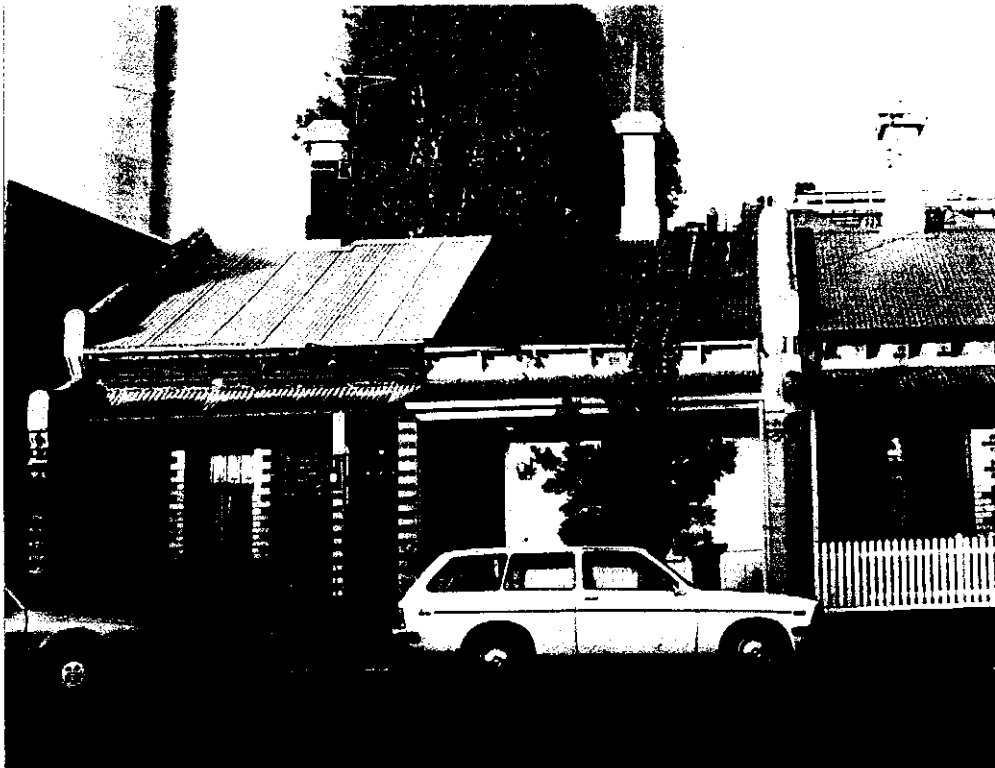
The terrace at 151-153 Langridge Street, Collingwood, comprises two single storey attached bichromatic brick houses, similar in design to the adjoining pair at Nos. 147-149. Walls are of brown face brick, with cream brick dressings and decoration to the central wing wall. Each facade has a door and single timber-framed double-hung sash window. There is a concave-roofed corrugated iron verandah. The single transverse gabled roof has bracketed eaves, is clad in corrugated iron and is penetrated by brick chimneys with rendered moulded caps.

The facade of No. 151 has been painted, as have the chimneys of both houses. Neither house retains a verandah frieze or original front fence.
