Building:	Terrace	Significance:	B
Address:	57-63 Oxford Street, Collingwood	Melway Map Ref:	2C D11
Building Type:	Residence	Construction Date:	1873-78
Architect:	Unknown	Builder:	Unknown

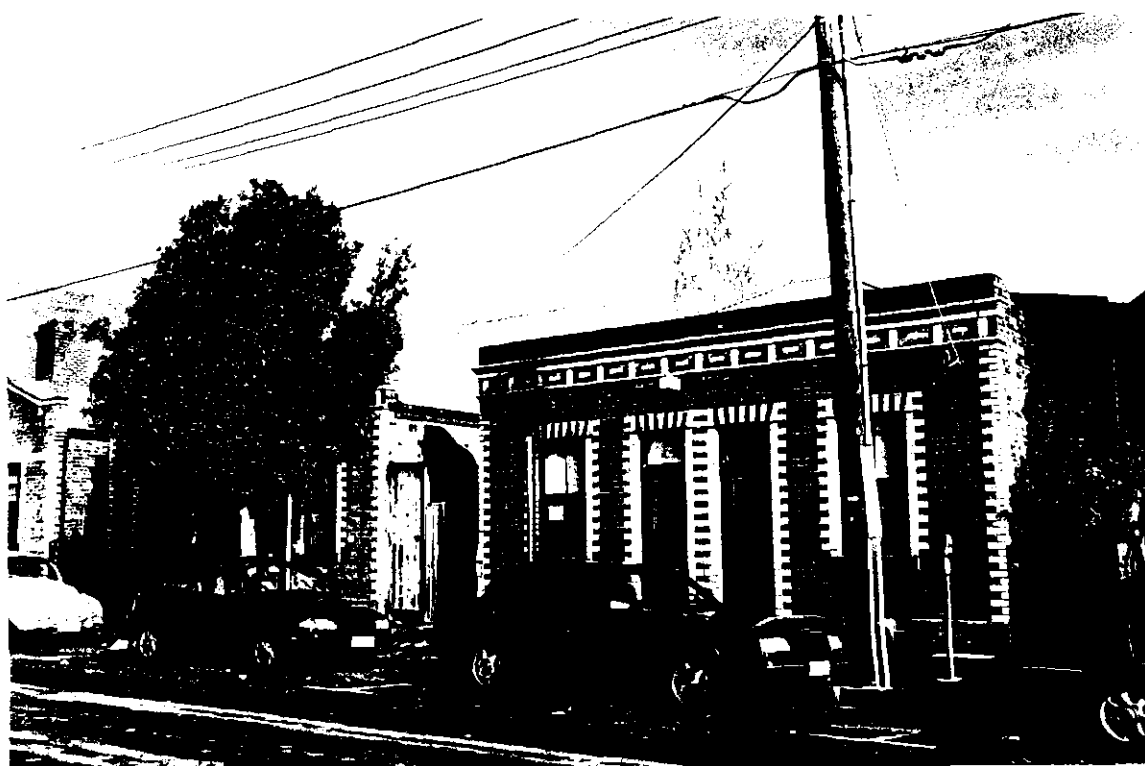
59-63 Oxford Street comprises two pairs of single storey, symmetrical, attached bichromatic brick houses built to the street alignment. The facade of each building has a pair of four-panelled timber doors with highlights, flanked by single timber-framed double hung sash windows with bluestone sills. The walls are of face red brick with a bluestone plinth, and with cream brick quoining to the building's corners, and to the door and window openings. The hipped corrugated iron roofs are partially concealed behind a modest brick parapet with a cream brick cornice and frieze.
