NAME: National Bank  
ADDRESS: 171 Smith Street  
CONSTRUCTION DATE: 1872-73  
ALTERATIONS/ADDITNS: Removal of roof parapet  
in 1967  
ARCHITECT: Leonard Terry  
BUILDER: Unknown  
FIRST OWNER: National Bank  
FIRST OCC./USE: Ditto/banking premises  
PRESENT OWNER: Ditto  
PRESENT OCC/USE: Ditto/banking premises  
CONSTRUCTION  
MATERIALS: Face bluestone and face  
freestone  
INTACTNESS/  
CONDITION: Externally intact apart from parapet  
AREA/STREETSCAPE: Part of recommended streetscape A18

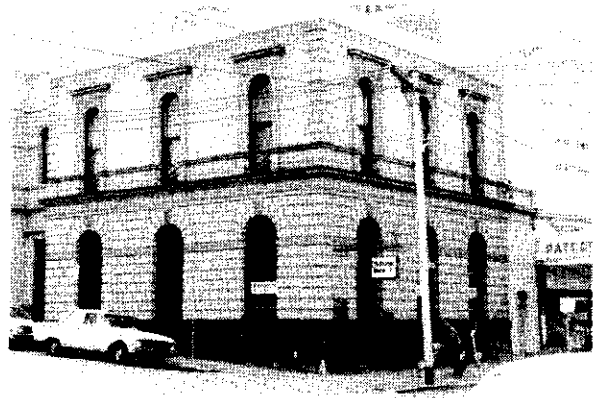
This bank was constructed for the National Bank in 1872<sup>1</sup> to the design of the architect Leonard Terry. It is superbly executed in face freestone with a bluestone plinth, and employs typical elements of Terry's work, combined to produce a harmonious and well proportioned building.

In 1967 the parapet was removed and replaced by an inappropriate cement capping. This has spoiled the harmony of the original design and detracts significantly from the overall composition.

It is recommended that this building be added to the Historic Buildings Register. Reinstatement of the original parapet is recommended and would result in a modest, superbly designed and executed bank building. It is also recommended that the bank be added to the Register of the National Estate and be specified under Clause 8 of the Town & Country Planning Act (Third Schedule).

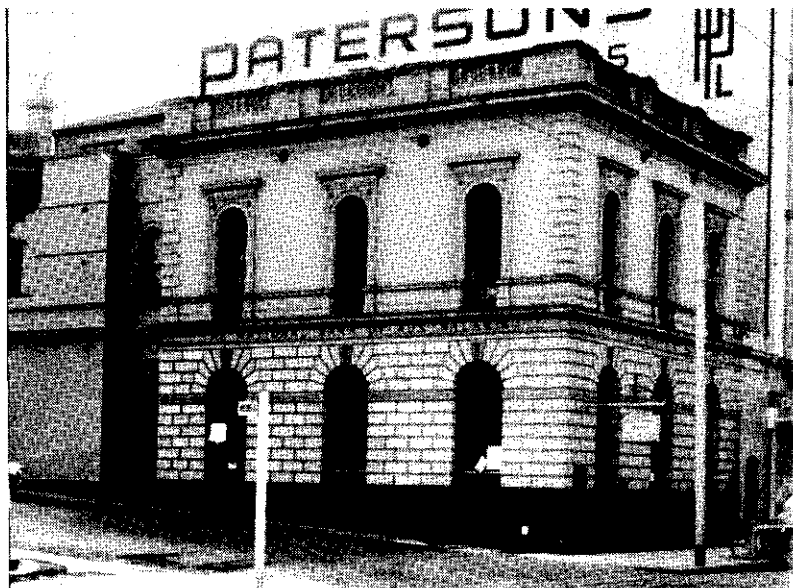
(33) National Bank, 1965

In 1967 the original parapet and dentillated cornice was removed<sup>2</sup> (due to structural instability) and replaced by a cement capping which ruins the original proportions of the building. Reinstated, this parapet would produce a building without comparison in Victoria as a harmonious modest bank building. It is remarkable that it has survived unpainted to this date, presenting such mellow building materials to the street facade.

2. Photo, dated April 1965, of original parapet. Held at the National Bank Premises Department. Drawings are also held, dated 9.1.1967 by Meldrum & Partners, Architect, with parapet drawings.

This building provides an extremely important corner streetscape element. The proportions and detailing of this building are beyond comparison. It is strongly recommended that the parapet be replaced to return this building to its original condition.
