CARLTON CONSERVATION STUDY BUILDING IDENTIFICATION FORM

NIGEL LEWIS AND ASSOCIATES
1984
Nigel Lewis Richard Aitken

BUILDING ADDRESS 558, 560, 562, 564 CANNING ST

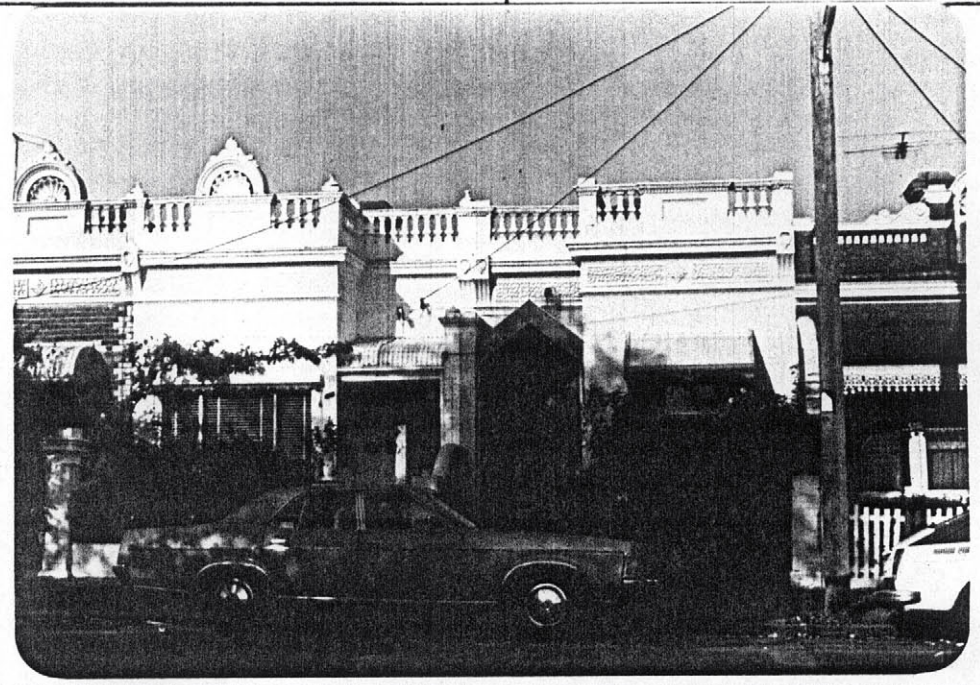
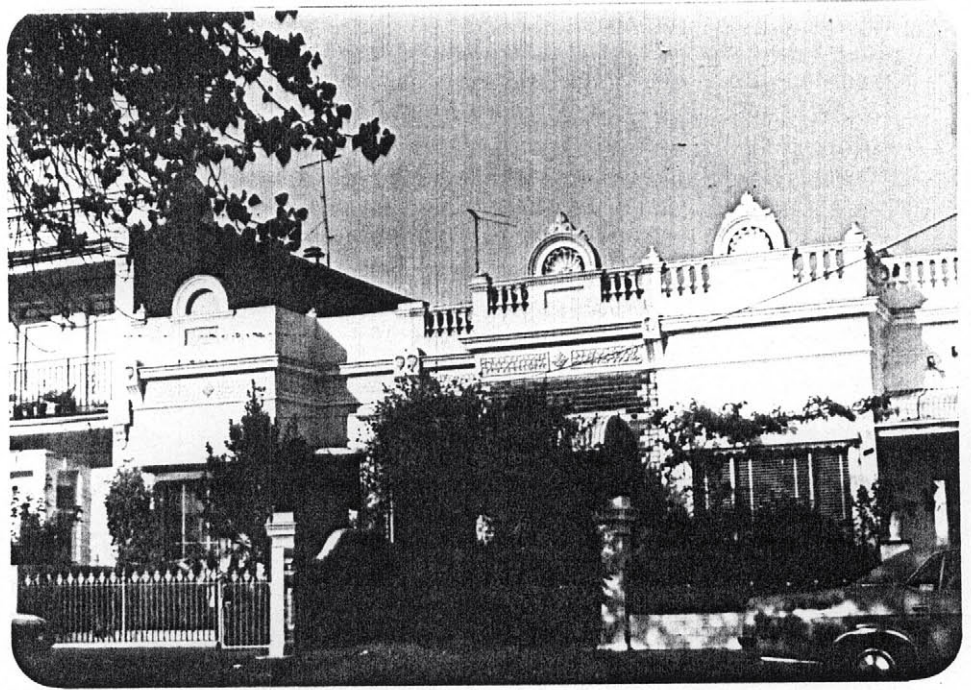
NOTABLE FEATURES/SIGNIFICANCE
 verandah decoration cast iron fence NOT 560
 unpainted cement render unpainted decorative brickwork retains evidence of early colours or finishes intact shop front post supported shop verandah elaborate/high standard design of cement rendered surfaces
 verandah roof and structure BREAK FRONT PARAPETS BRUSTRATED Verandah roof and structure
 fenestration intact 558

ALTERATIONS AND RECOMMENDATIONS		RECS		RECS	
NOS	SYMPATHETIC	INAPPROPRIATE	EXTREMELY INNAPPROPRIATE		
558, 560				PARAPETS BWC	RAM
560, 564				WINDOWS + OPENINGS	?
564				RENDERED BWC	
562				SAND BLASTED BWC	?
560		REMOVE			S
564				PARAPETS	
				STAMPED	75
562	WINDOW				
558, 562	VERANDAH

0 = REINSTATE ORIGINAL DESIGN; S = REINSTATE SYMPATHETIC ALTERNATIVE; R = REMOVE; RAM = REMOVE BY APPROVED METHOD
