CARLTON CONSERVATION STUDY BUILDING IDENTIFICATION FORM

NIGEL LEWIS AND ASSOCIATES
1984
Nigel Lewis Richard Aitken

BUILDING ADDRESS *876, 880, 884, 888 DRUMMOND ST*

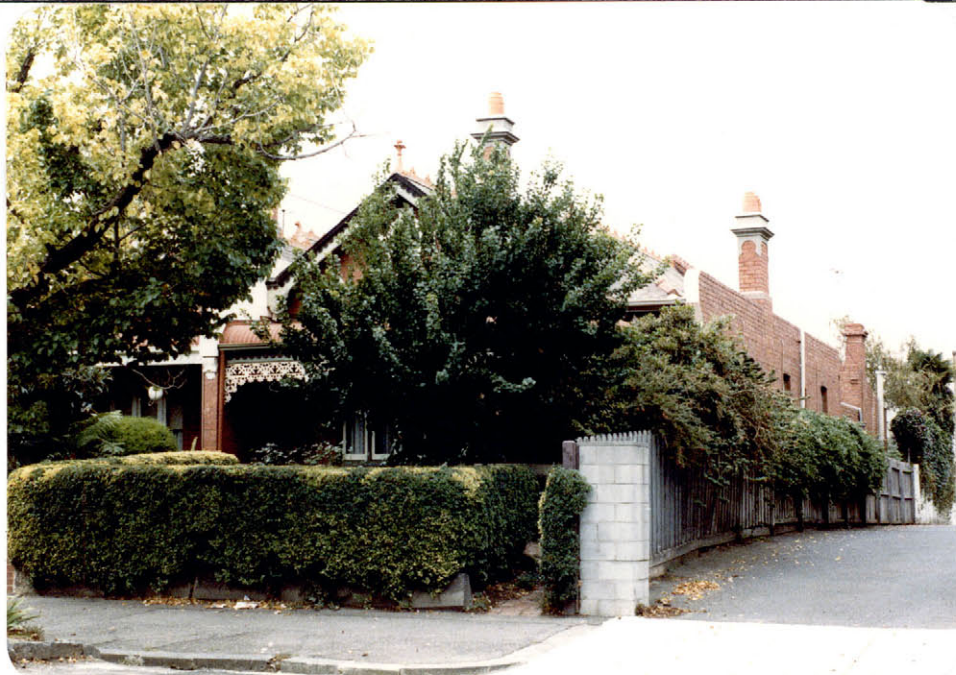
SLATE ROOF, ROOF + GABLE FORMS, CHIMNEYS. UNUSUAL GROUP OF TWO SEMI-D PAIRS.

NOS	SYMPATHETIC	RECS	INAPPROPRIATE	RECS	EXTREMELY INAPPROPRIATE	RECS
<i>876</i>	<i>FENCES</i>					
<i>880, 884, 888</i>			<i>FENCES</i>	<i>S</i>		
<i>886</i>			<i>VER. DEC. + COLS MISSING</i>	<i>S</i>		
<i>884</i>			<i>VER. DEC. MISSING</i>	<i>S</i>	<i>PAINTED B/WK</i>	<i>RAM</i>
<i>888</i>			<i>RENDERED PARAPET</i>	<i>S</i>
