CARLTON CONSERVATION STUDY BUILDING IDENTIFICATION FORM

NIGEL LEWIS AND ASSOCIATES
1984
Nigel Lewis Richard Aitken

BUILDING ADDRESS *94, 96, 98, 100 MELBURN ST*

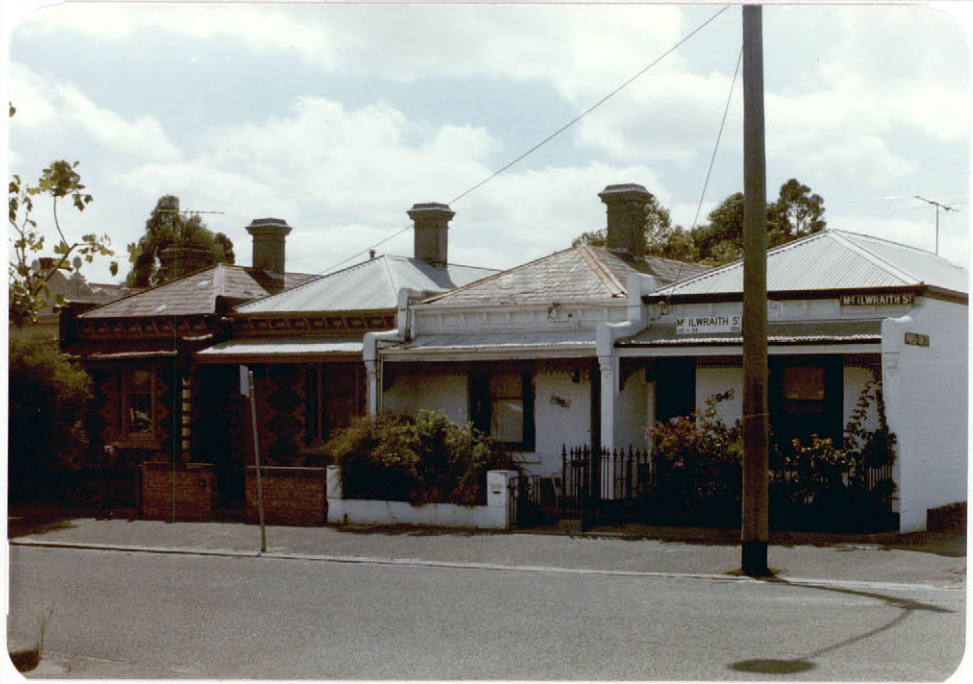
~~CI fence (94)~~
98, 100

NOS	SYMPATHETIC	RECS	INNAPPROPRIATE	RECS	EXTREMELY INNAPPROPRIATE	RECS
<i>94, 98</i>					<i>PRINTED BRICKWORK</i>	<i>RAM</i>
<i>94</i>			<i>MISSING CHIMNEY</i>	<i>0</i>		
<i>96, 98</i>			<i>FENCE</i>			
<i>94</i>	<i>CI fence</i>					
<i>100</i>	<i>fence</i>					
<i>All</i>			<i>MISSING/REPLACED IRON</i>

DIFFICULT TO ASCERTAIN AUTHENTICITY OF IRON OF 96

0 = REINSTATE ORIGINAL DESIGN; S = REINSTATE SYMPATHETIC ALTERNATIVE; R = REMOVE; RAM = REMOVE BY APPROVED METHOD
