CARLTON CONSERVATION STUDY BUILDING IDENTIFICATION FORM

NIGEL LEWIS AND ASSOCIATES
1984
Nigel Lewis Richard Aitken

BUILDING ADDRESS 607 NICHOLSON ST

TYPE FORMER BANK
IF NOT RESIDENCE

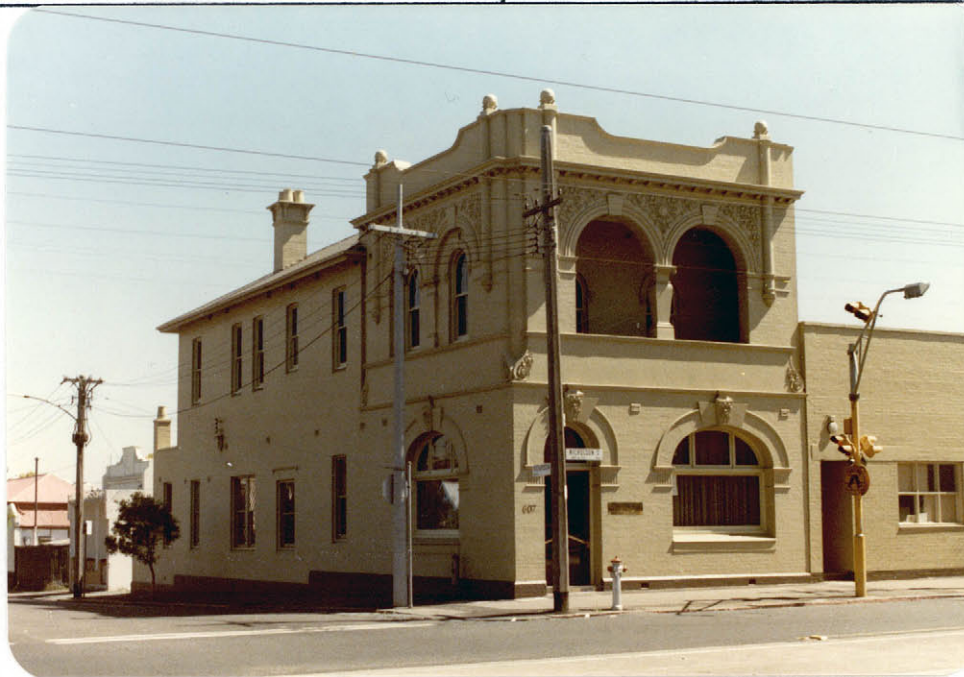
Similar form to many banks erected c. 1905-15.

☒

| | | | <u>DOOR</u> | <u>S</u> | <u>PAINTED BRK</u> | <u>RAM</u> |

PAINT REMOVE WOULD DRAMATICALLY IMPROVE.
