CARLTON CONSERVATION STUDY BUILDING IDENTIFICATION FORM

NIGEL LEWIS AND ASSOCIATES
1984
Nigel Lewis Richard Aitken

BUILDING ADDRESS *765, 767, 767A, 769 NICCOLSON ST*

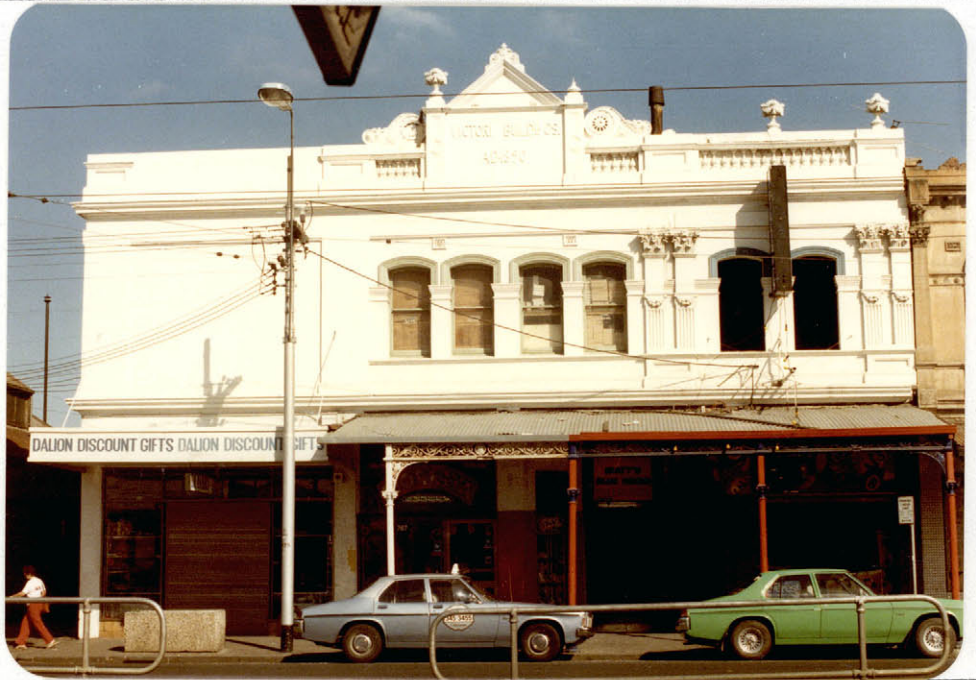
NOTABLE FEATURES/SIGNIFICANCE

SHOPFRONT + TILES

verandah decoration

cast iron fence

UNUSUAL SPACED ENTRY WALKWAY + GATE.

NOS	SYMPATHETIC	RECS	INAPPROPRIATE	RECS	EXTREMELY INAPPROPRIATE	RECS
<i>765</i>			<i>SECTIONS OF VERANDAH MISSING</i>	<i>0</i>	<i>FEWER PUTTING + DECORATION ALTERED</i>	<i>0</i>
<i>765, 767*</i>			<i>SHOPFRONTS</i>	<i>5</i>	<i>PAINTED BRICK LOWER WALKWAY WALLS.</i>	<i>RAM</i>
<i>765</i>					<i>'AWNING</i>	<i>0*</i>

*767, VERANDAH GUTS ABOVE SHOP FRONT
* POST SUPPORTED VERANDAH*

0 = REINSTATE ORIGINAL DESIGN; S = REINSTATE SYMPATHETIC ALTERNATIVE; R = REMOVE; RAM = REMOVE BY APPROVED METHOD
