GREATER GEELONG OUTER AREAS HERITAGE STUDY: STAGE 2

Existing Use/Type Religious	Key Dates Original 1873	Site Address Street/Site Name Hitchcock Avenue
Survey Date 20/07/1998	Cons Man Plan High Priority	No. 71
Major Changes 1891, 1942,47		Town/Suburb Barwon Heads
		Postcode 3227
Recorded By David Rowe	Precinct Name	Current Site Name Barwon Heads Uniting Church

Site Address	No.	Street/Site Name	Town/Suburb	Postcode
	71	Hitchcock Avenue	Barwon Heads	3227
	Site Name			
	Barwon Heads Uniting Church

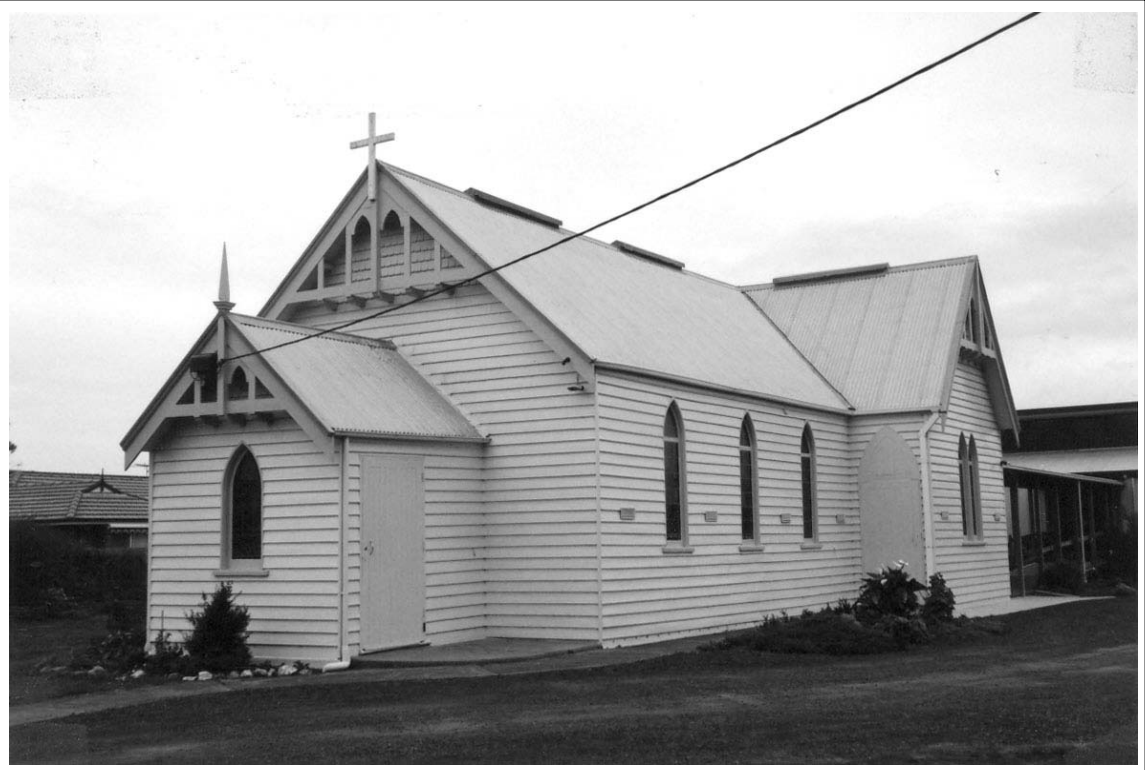
Site Address	No.	Street/Site Name	Town/Suburb	Postcode								
	71	Hitchcock Avenue	Barwon Heads	3227								
			Site Name	Barwon Heads Uniting Church								
Description												
<p>The site at 71 Hitchcock Avenue has visual connections to some tall pine trees and an avenue of gum trees at the north end, together with single storey residential, religious and commercial buildings of mixed styles and periods. This Church building has large front and side setbacks, due to the substantial size of the land. These setbacks are shown on the 1994 Barwon Water Amended Plan of Drainage.⁴</p> <p>The single storey, symmetrical, horizontal weatherboard Victorian Carpenter Gothic building is characterised by a central gable roof form, with a minor porch gable projecting towards the street frontage and transept gables projecting at the sides. These roof forms appear to be clad in galvanised corrugated iron. Timber framed and pointed leadlight windows adorn the elevations. An early pointed timber entrance door is situated on the north projecting transept, while a recent door is located on the front porch.</p> <p>Early decorative features of the design include the timber flying gable fretwork and finial.</p>

It is highly recommended that a Conservation Management Plan be carried out on the property.
