Name	St Hilary's Church of England Parsonage	Reference No	
Address	34 Rowland Street, Kew	Survey Date	13 December 2005
Building Type	Residence	Grading	B
Date	1889	Previous Grading	B

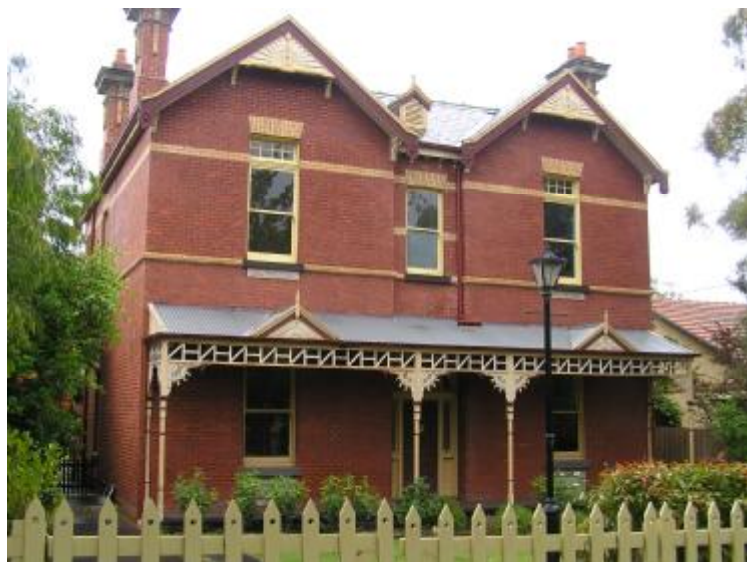
34 Rowland Street is a two storey house in red brick – recently tuck pointed - with a reconstructed skillion verandah with a galvanized iron roof, timber fretwork columns with cast iron lace quadrants at each column, miniature pediments and a Japanned frieze in timber box frames. The pediments line up with the windows directly above and behind them.

With the exception of the reconstructed verandah (refer discussion below) and alterations to the central first floor window (also discussed below), the principal elevation appears to be intact to its original form. It comprises two gabled breakfront pavilions, each framing a single tall first floor sash window and fanlight, and separated by a recessed front wall with a central window, somewhat smaller than the other two. Window heads at both ground and first floor levels are in cream brick and the sills are in bluestone. Rendered cement panels are located below both ground floor windows.

The central recessed section of the facade is surmounted by the main transverse roof slope, which incorporates a lantern or dormer-like vent immediately above and behind the central window. The two flanking gables are topped by infill panels near their bargeboard apexes, and the panels have sunburst reliefs in each. The red brick of the façade is relieved by a cream brick moulded string course at first floor sill level and a cream brick band at the level of the fanlight frames. Both extend across the façade and continue along the length of the side walls. The recent tuck pointing has been undertaken in a relatively crude manner.

The main pitched roof forms are predominantly clad in slate with galvanized Colorbond ridge capping. A central rectangular section of roof is located between the principal gables and extends back from the front transverse slope; this is not visible from the street but from the aerial view appears to be clad in Colorbond or similar (replacing an earlier lead sheet cladding over wood core rolls). The chimneys are red brick with the unusual combination of stuccoed cornices and half-length vertical brick strapwork. The single-storey rear addition is not visible from the street.
