Manningham Heritage Garden & Significant Tree Study

Heritage Garden Information Sheet

Name of Property: "Sunningdale"

Location: 16 Old Warrandyte Road, Donvale

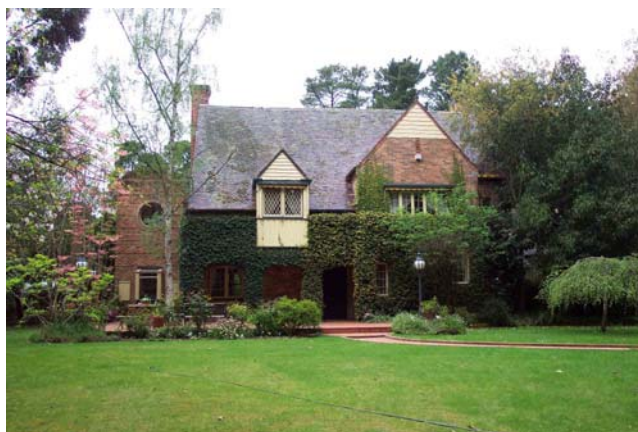
Notes – The garden is believed to be contemporary with the construction of the house in 1941. Set behind a significant pine reserve, the house and garden are largely screened from the road. Consisting of a sweeping gravel driveway, central pond and a number of garden beds, it would appear that the garden was designed to accentuate the house.

Other: Much of the front garden appears to be intact with mature trees, informal garden beds and lawn, with a central pond. The rear garden has been altered over the years to include a tennis court, swimming pool and substantial paving.

Other: A number of the lamp posts, mainly around the house, appear to be original elements, while a number of later additions are located around the driveway. There is a small statue within the pond and a footbridge from the edge of the pond through the garden bed.

Maintenance Practices/Requirements: Garden currently managed by owners. Weed species, such as Cotoneaster, should be removed from garden beds. Garden beds should be re-planted with species contemporary with the era of the house, particularly the garden bed to the north of the driveway/entrance, where planting is almost non-existent. A number of the pines are declining and/or becoming hazardous, with some requiring removal.
