PLACE IDENTIFICATION FORM

44 Wattle Road

44 WATTLE ROAD

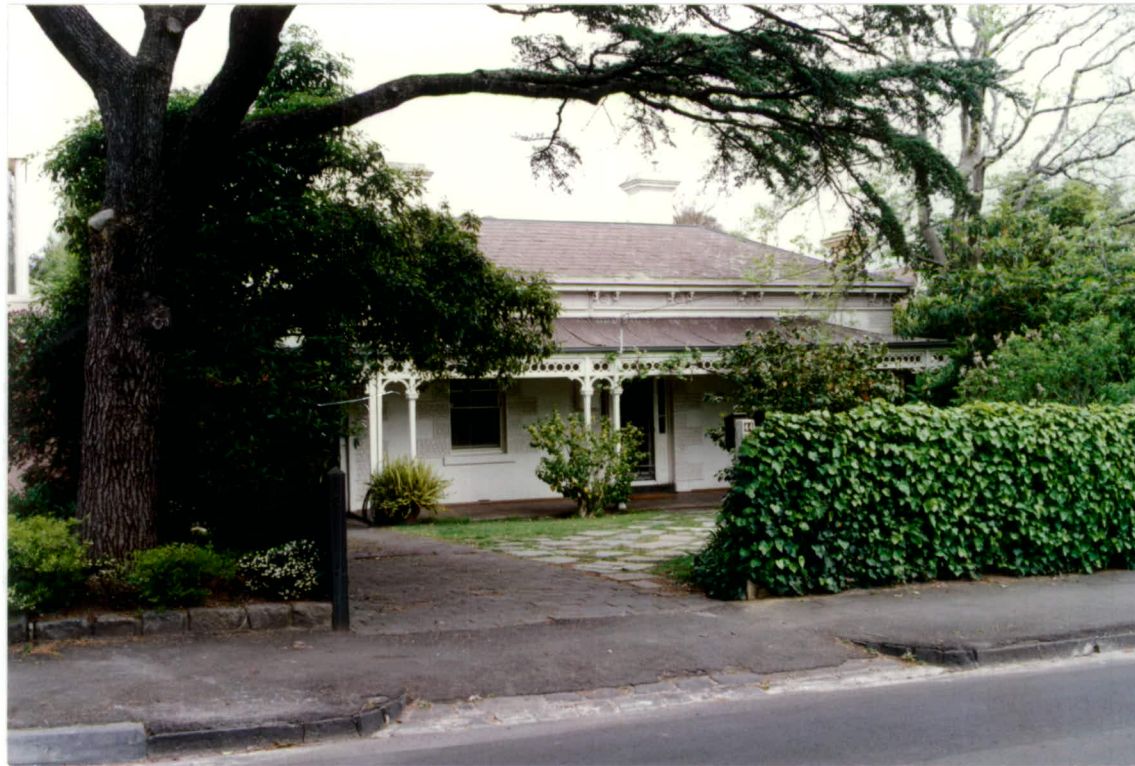
A double fronted, single storey, rendered villa with timber verandah (recently extended across the drive). The render decoration is particularly fine. At the corners and at the window and door openings, are oversized quoins, vermiculated in the centre and enclosed in a regular border. At the eaves vermiculated panels are interspersed with delicate paired brackets and a modillion. The verandah presents an equally intricate patterning, using paired timber posts with delicate, small, half round brackets, and a frieze panel of fretwork circles. The overall effect is picturesque.
