GREATER GEELONG OUTER AREAS HERITAGE STUDY: STAGE 2

Site Address	No.	Street/Site Name	Town/Suburb	Postcode
	Adj. 51	Hitchcock Ave	Barwon Heads	3227
			Site Name	Post Box

Post Box

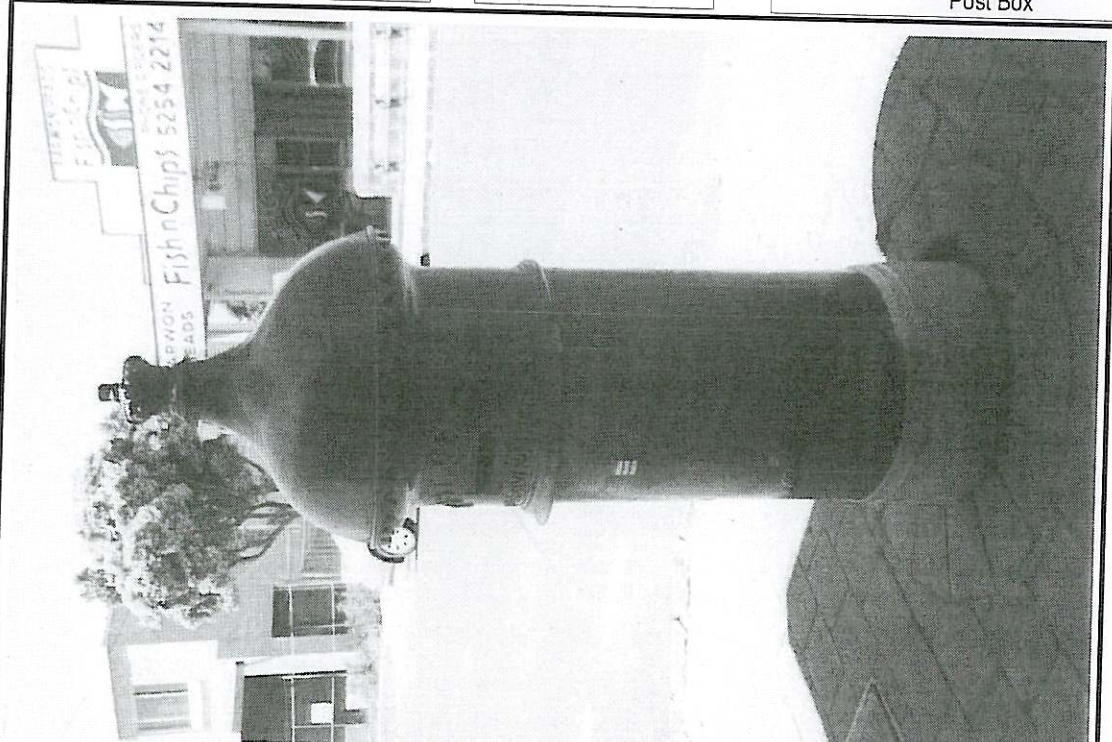
The Post Box is of the circular column type with an ogee shaped roof capped by a crown. It has a slightly projecting band and a large low door with a handle comprising a fist clutching a rod. The receiving mail opening is above the projecting band.

The Barwon Heads post box is of the circular column design. The first type of circular column design boxes feature two bands of embossed rosettes and a low small door and a fist clutching a rod as the handle. These type of boxes were popular between 1860 and 1875. The type at Barwon Heads, with its plain band and large door opening, were most numerous and common between 1890-1920.
