KEW CONSERVATION STUDY 1987
BUILDING IDENTIFICATION FORM

GRADE B BUILDING

Address: 1 Fernhurst Grove

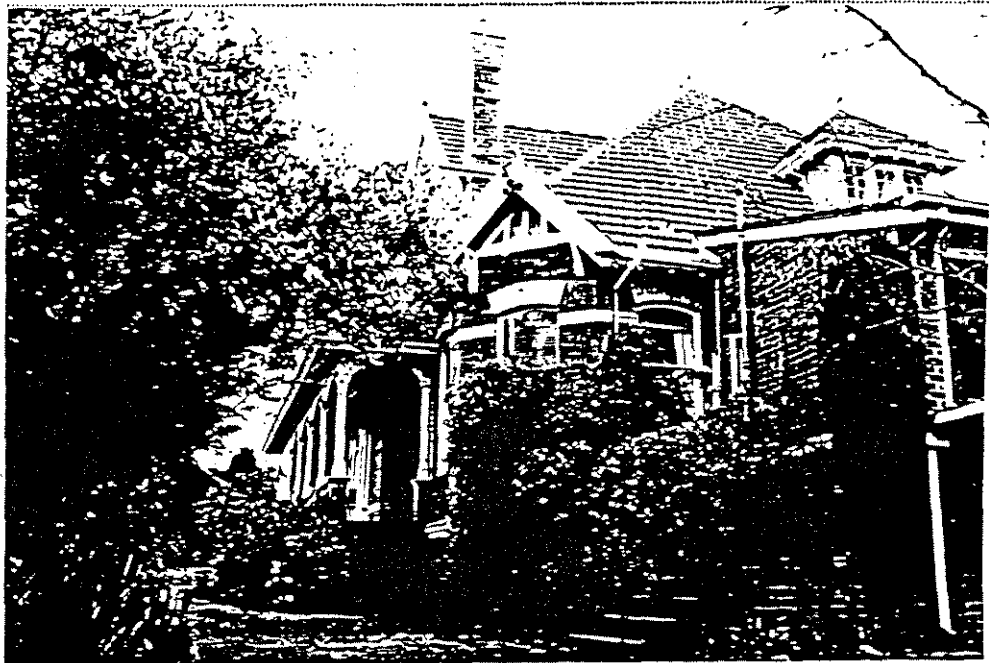
Roof had chimneys, ridge tiles

Comment Additions to front detract

1 Fernhurst Grove is of significance as a distinguished example of the Federation Domestic Queen Anne Revival. Notable features include the verandah, door and window joinery, Marseilles tile roof, terracotta ridge tiles and finials and brick chimneys. Shingles to attic windows and the half timbering of gables is also intact and integral to the building's significance.

An addition to the front and the enclosure of part of the verandah are detrimental to the building's integrity and appearance. The fence is also inappropriate.
