KEW CONSERVATION STUDY 1987
BUILDING IDENTIFICATION FORM

GRADE B BUILDING

Address: 32 Belmont Avenue

Use: Original House Current Hostel (Institution)

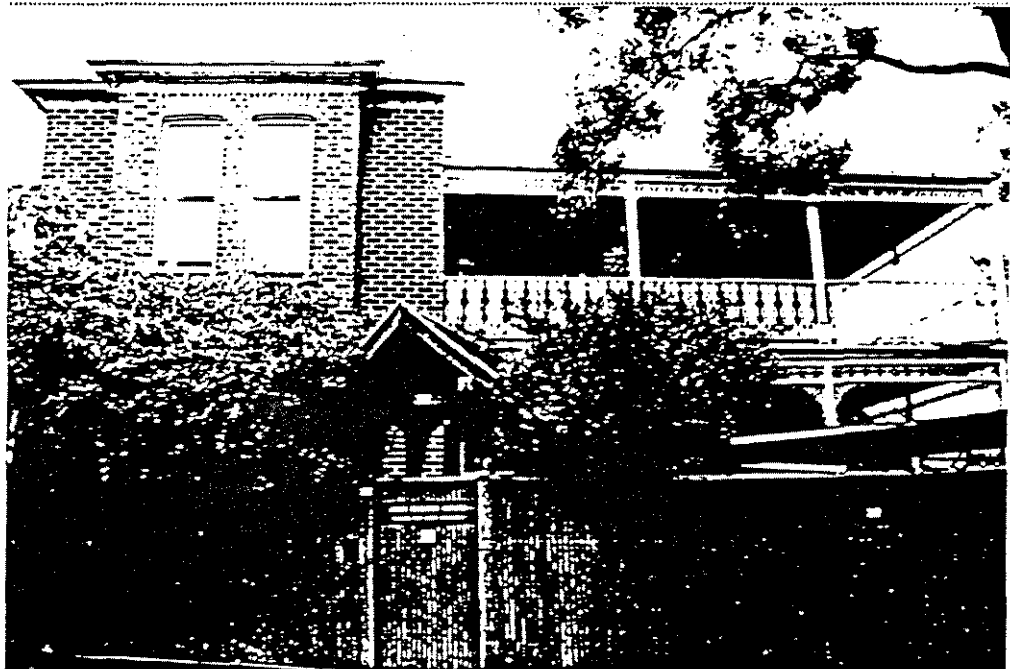
Comment Lych gate - 1915?

Cypress prob. orig. to house

John Cannon House is a largely intact late Victorian polychrome house. Original elements integral to its significance include the unpainted brick walls, the cast iron of the two storey verandah, the window and door joinery, the slate roof and the chimneys. The lych gate, though probably a later addition, is also of significance through its long association with the site, as are various elements of the garden.

The building is largely obscured by a high and inappropriate fence. The chimney at the south
