KEW CONSERVATION STUDY 1987
BUILDING IDENTIFICATION FORM

GRADE B BUILDING

Address: 45 Belmont Avenue

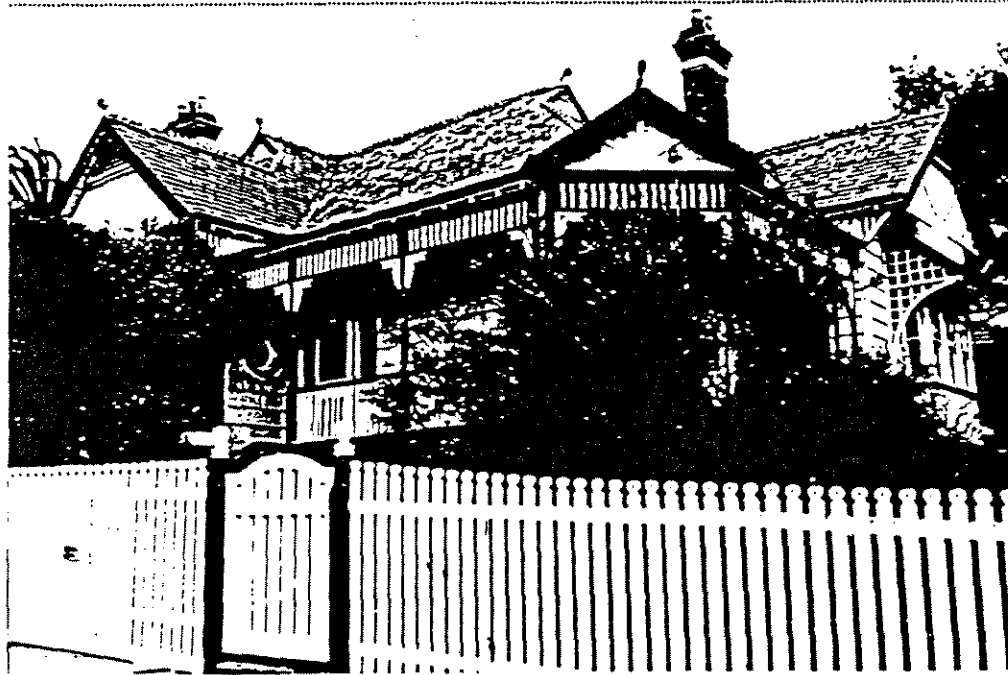
PERIOD	SIGNIFICANT ELEMENTS
<input type="checkbox"/> Mid-Victorian	<input checked="" type="checkbox"/> Walls <u>Incl. window hood</u>
<input type="checkbox"/> Late Victorian	<input checked="" type="checkbox"/> Roof <u>Incl. chimneys, ridge tiles</u>
<input checked="" type="checkbox"/> Edwardian	<input checked="" type="checkbox"/> Joinery <u>Incl. leadlight.</u>
<input type="checkbox"/> Inter-War	<input checked="" type="checkbox"/> Verandah <u>Incl. balustrade</u>
<input type="checkbox"/> Post WWII	<input checked="" type="checkbox"/> Fence <u>(Partially intact)</u>

Comment Araucaria in garden appears original

45 Belmont Avenue is significant as a large and relatively intact single storey timber Federation villa. Notable elements include the joinery of windows and doors, including leadlight, window canopies, mock ashlar walls, timber verandah and the half timbering of the gables. The slate roof, with terracotta ridge tiles and finials and brick chimneys, is intact and integral to the building's significance. The garden appears to be largely original and appropriate, and the fence is partially original.
