This sheet should be read in conjunction with Graeme Butler & Associates, *Geelong City Urban Conservation Study*, Vol. 1-5, 1991.

11 Balliang Street

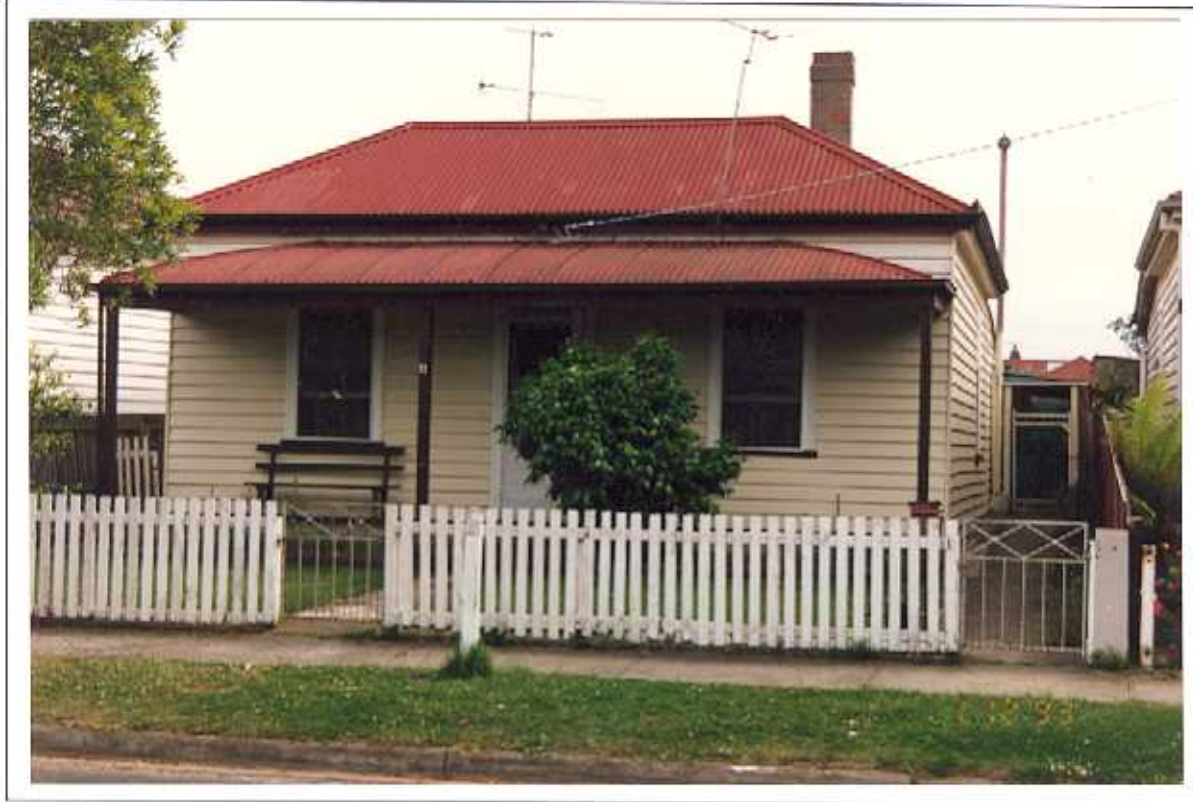
This substantially intact Victorian residence with timber skillion at the rear, has a symmetrical facade constructed of weatherboard cladding. The corrugated iron roof is hipped with a hipped convex verandah featuring simple timber posts. The windows are typical Victorian double hung sash openings with projecting sills. The central entrance has a typical highlight and is hidden by a security door. The verandah is concrete but would have originally been timber. A tall brick corbelled chimney protrudes from the roof. The fence at the front of the site is timber and of considerable age. The building is very similar in form and detail to the adjacent structure at 13 Balliang Street, and forms part of the residential streetscape.
