Heritage Overlay No.: 048
Citation No.: 077
Place: Former Murphy Dam

Other Names of Place: None
Location: 209-247 Plumpton Road Diggers Rest (Lot S2 PS 434718)
Critical Dates: Construction: likely mid-late 1850s.
Existing Heritage Listings: None
Recommended Level of Significance: LOCAL

Statement of Significance:

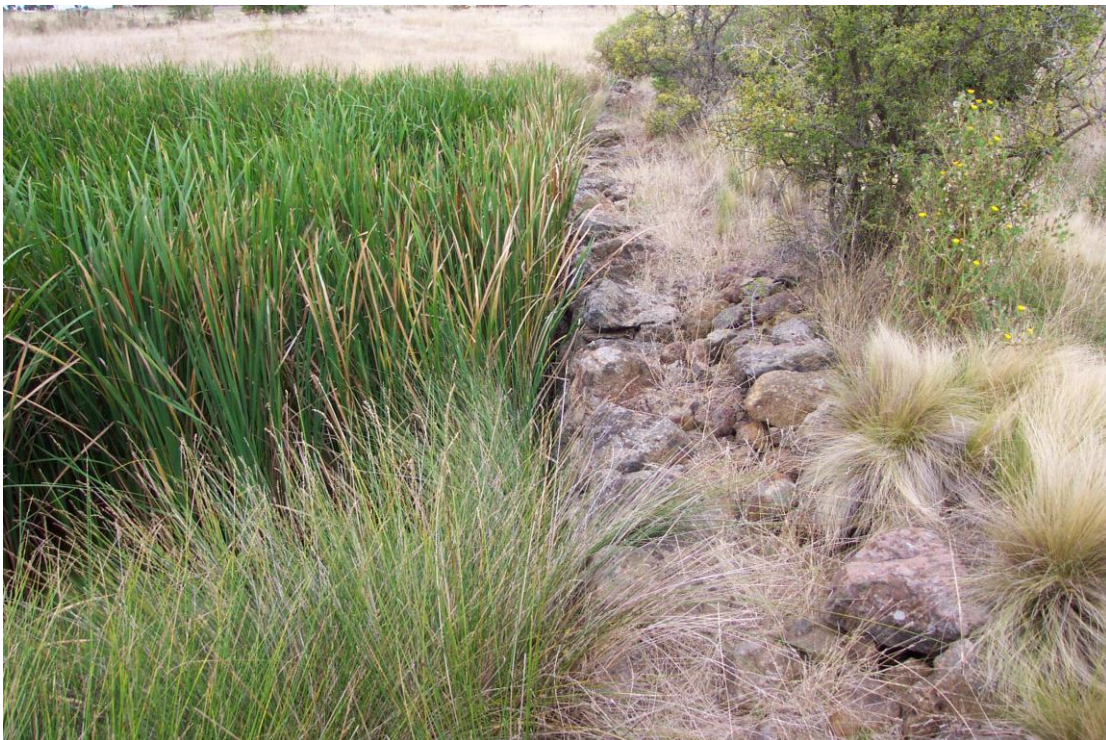
It is a relatively small dam in comparison to the stone dams constructed by Clarke and other larger farmers in the Shire. It is about 25 metres long, and of reasonable height, being c.1.5 metres above the waterline. It is of ‘squared’ drystone construction with an earth wall on the downstream side, and having an outlet channel at the west end. The dam is effective, containing substantial water, but is overgrown with reeds and consequently difficult to view properly. The north end of the stone wall is partly broken, and capping stones partly missing.

The dam is a very good example of dry stone stone work. It has a vertical face on the water side, is about a metre wide on top, and is very well constructed.

Good. But overgrown with rushes at present, so difficult to obtain a good view of it.

Substantially Intact (a small portion is broken, with coping stones removed)

Recommended for inclusion in the Melton Planning Scheme Heritage Overlay.

- A preliminary archaeological survey of the former Murphy drystone wall dam, and the associated complex of drystone walls, has the potential to provide further

information regarding early farming practices in the dry plains areas of the Shire of Melton, and is desirable.
