Heritage Overlay No.: 084

Citation No.: 227

Place: Melton Weir

Location: Nixon Street Melton (over Toolern Creek)

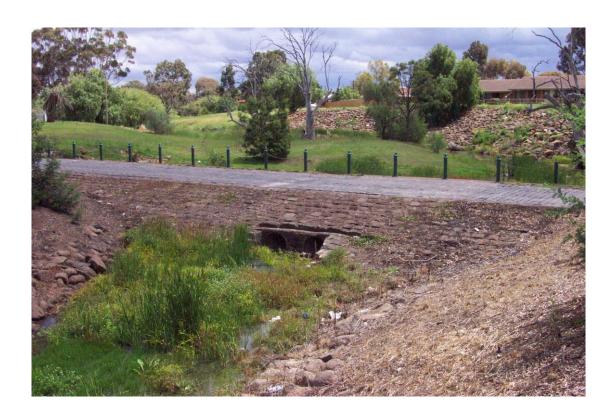
The causeway across the Toolern Creek, McKenzie Street / Reserve Road, Melton was originally constructed as a combined bridge and weir. It was described at the time of its construction as consisting of a concrete wall 140 feet (42.5 metres) long, and 12 feet (3.5 metres) deep. This wall was 2 feet wide at the top, and 4 feet at the bottom, embedded in solid rock. It was filled with clay and pitched on the front and top with 9 inch pitchers. The roadway was 20 feet (6 metres) wide. It had a 'strong chain' running through posts on the downstream side of the roadway (which was nevertheless washed downstream in times of heavy flood), and a wire cable on the upstream side. It is not known whether it was built with the sluice valve and outlet pipe that some local people thought would be necessary to keep it clean and effective. When completed it was judged to have 'the appearance of a strong piece of work', that would 'speak for itself in time'.

The battered sides of the structure are still paved with roughly squared bluestone blocks. Its road pavement is also cobbled with bluestone, although this may have been renewed in recent years. Two reinforced concrete pipes have been inserted into the bottom of the dam to carry the stream, effectivelyl converting the weir and ford into a simple causeway. This alteration is sizeable and visually intrusive, but not large enough to diminish the appearance or overall integrity of the substantial causeway structure.

The weir was described as consisting of a concrete wall 140 feet (42.5 metres) long, and 12 feet (3.5 metres) deep. This wall was 2 feet wide at the top, and 4 feet at the bottom, embedded in solid rock. It was filled with clay and pitched on the front and top with 9 inch pitchers. The roadway was 20 feet (6 metres) wide. It had a 'strong chain' running through posts on the downstream side of the roadway (which was nevertheless washed downstream in times of heavy flood), and a wire cable on the upstream side. When completed by the end of August 1890 it was judged to have 'the appearance of a strong piece of work', that would 'speak for itself in time'.¹⁴
