Heritage Overlay No.: 104
Citation No.: 292
Place: Moloney's Farm Site and Water Reserve

Other Names of Place: 'Moloney's Water Reserve'
Location: Main Historic Place: 1884-1908 Mount Cottrell Road, Mount Cottrell (west side). Including former Moloney property and boundary dry stone walls; also the Water Reserve 2182-2356 Boundary Rd, Mt Cottrell (east bank of Werribee River).
Critical Dates: Historic Dry Stone Wall: 2182-2356 Boundary Road, Mount Cottrell c.1871-72.
Existing Heritage Listings: None. Western Region Rural Heritage Study: 'worthy of assessment'.¹
Recommended Level of Significance: LOCAL

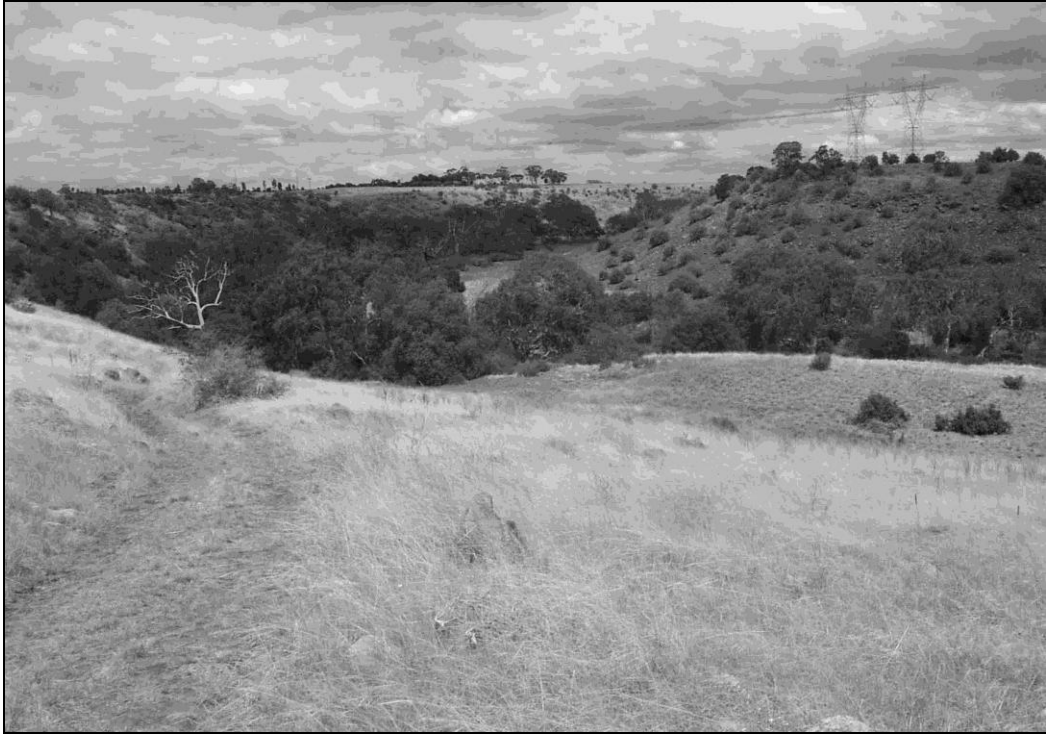
The Water Reserve itself comprises some 21 acres 1 rood and 20 perches of undeveloped land along the east bank of the Werribee River. It is accessed by a track cut into a steep escarpment which links the alluvial flats with the plains above. There are numerous introduced plants lining the track including briar rose, fennel, peppercorns and box thorn. The track is very steep and leads to a natural ford across the Werribee River. To the north of the water reserve is an old pumping station with intact machinery leading to a steel pipe which rises up the escarpment, presumably to provide water to the farms near Moloney’s. The Shire of Melton has recently been made managers of the area and are seeking to undertake weed control and revegetation works here.

‘Maloney’s [sic] Water Reserve’, showing the track leading down the escarpment to the Werribee River.

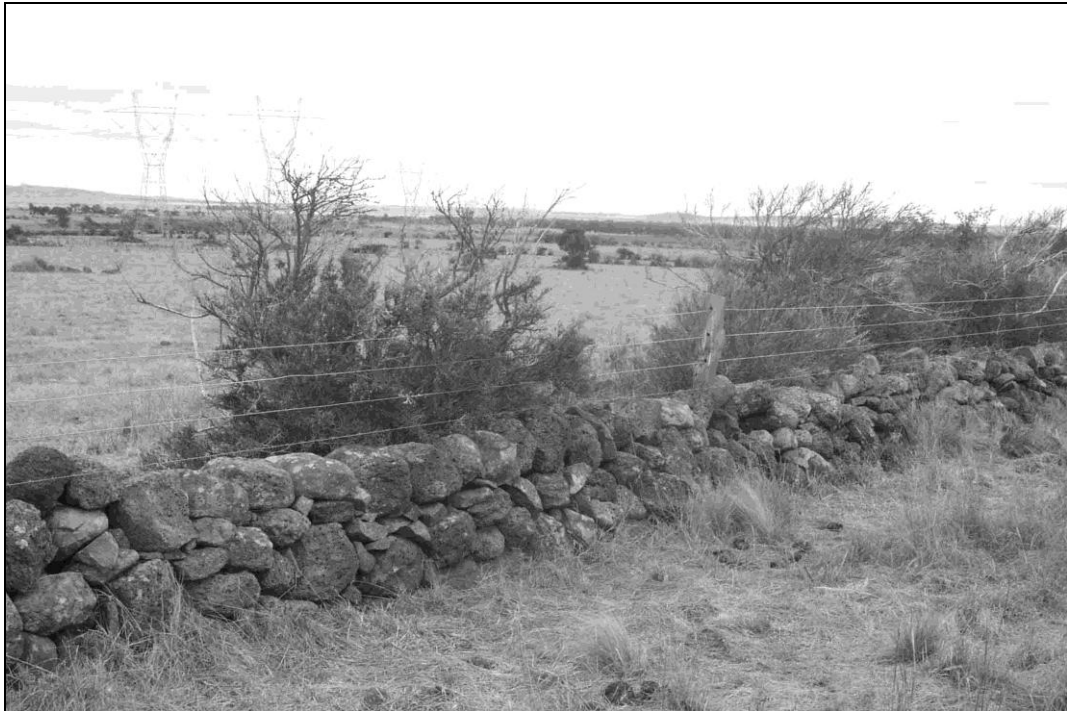
The boundary of the original 72 acre property was originally well enclosed with dry stone walls that can be definitively date to the period 1871 to 1874. The northern boundary wall is in excellent condition, with capping course intact, and consistent/even in structure over its length. It has some native Tree Violet, and a new post and wire fence behind it. The southern boundary wall, nearest the house, is in relatively poor structural condition, but remains substantial, and is of added significance as the boundary wall to the Water Reserve (known locally as ‘Maloneys [sic] Water Reserve’). This is matched by another similar wall on the southern side of the right-of-way leading to the Water Reserve. Both walls have native Tree Violet, probably self-sown, along their lengths.

Drystone wall in good condition on the north boundary of the Moloney property.
