Heritage Overlay No.: 048
Citation No.: 077
Place: Former Murphy Dam

Other Names of Place: N/A
Location: 209-247 Plumpton Road Diggers Rest (Lot S2 PS 434718)
Critical Dates: Construction: likely mid-late 1850s.
Existing Heritage Listings: None
Recommended Level of Significance: LOCAL

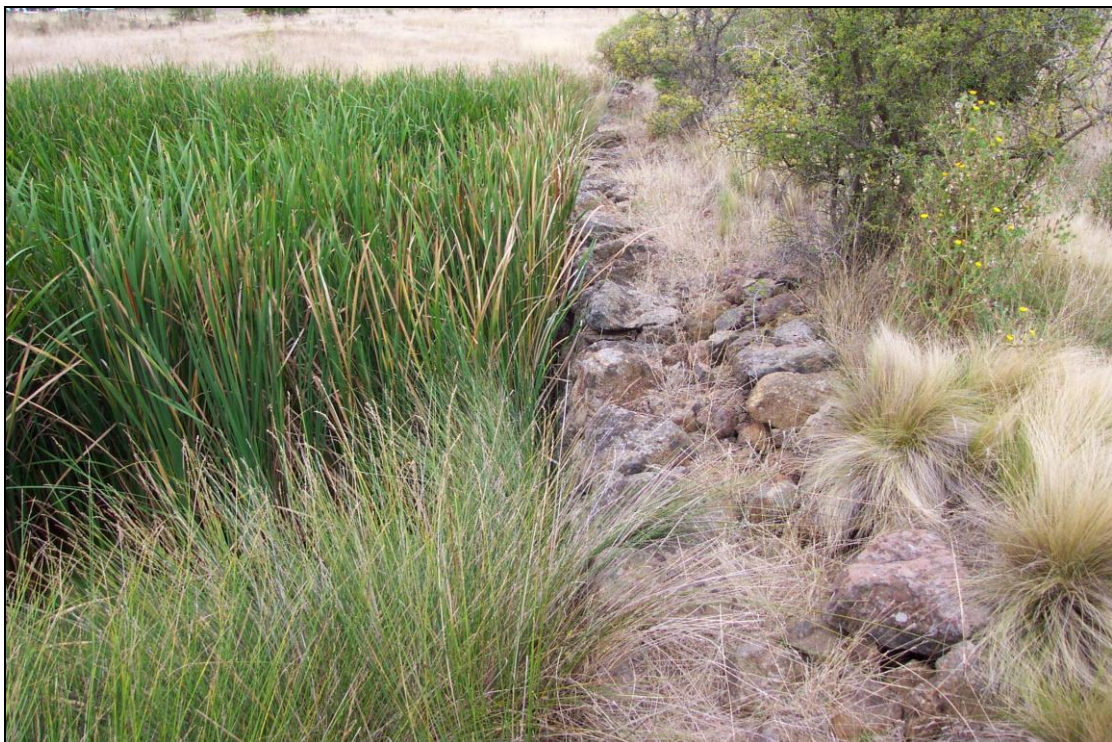
The former Murphy drystone wall dam, Diggers Rest, is aesthetically and structurally significant at the LOCAL level (AHC D2). It is a neatly constructed and highly intact dry-stone structure, with a vertical face on the dam side constructed of partly shaped local bluestone and fieldstone. Although now overgrown with reeds it still holds water.
