Heritage Overlay No.: 070
Citation No.: 188
Place: Darlingsford Barn

Other Names of Place: N/A
Location: 13-15 Darlingsford Boulevard, Melton
Critical Dates: Construction: c.early 1870s
Existing Heritage Listings: None
Recommended Level of Significance: LOCAL

Statement of Significance:

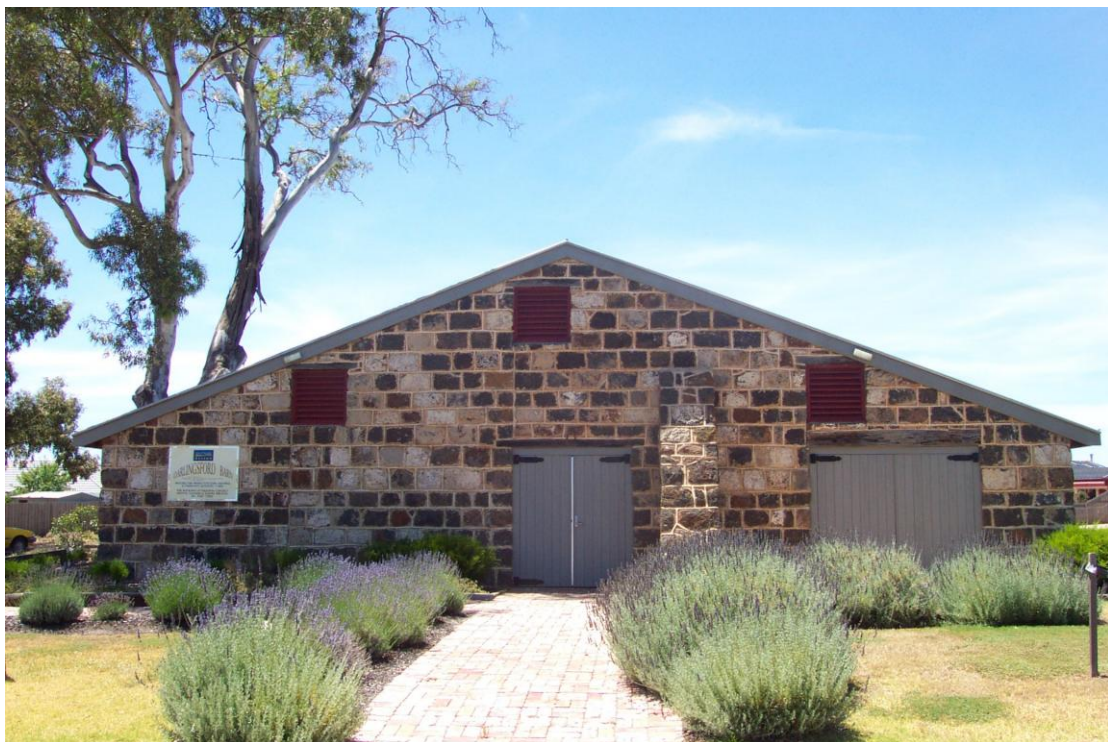
Darlingsford Barn at 13-15 Darlingsford Road has architectural interest. The broad gable roof form and coursed, squared rubble bluestone wall construction are important Victorian vernacular design elements that may reflect the original form and construction of this considerably altered building.
