# City of Geelong Urban Conservation Study Locally Significant Sites

### 118 Maud Street

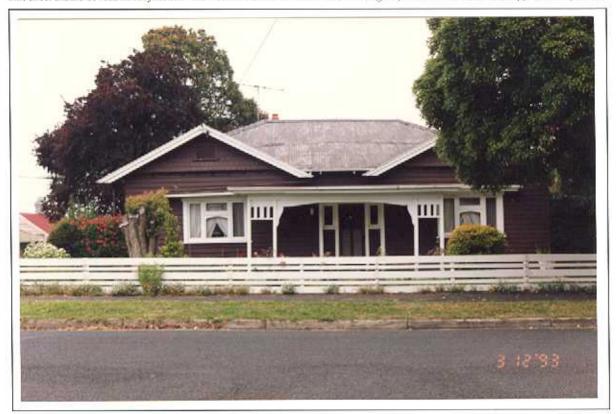
118 Maud Street is a substantially intact double fronted timber residence retaining many notable Bungalow details. The facade is symmetrical with two prominent gables flanking a central entrance with verandah porch. The main corrugated iron roof is a large medium pitched hip. Both gables have imitation timber shingles as an infill panel, wide barge boards, decorative vents, and tripartite casement windows with lead light glazing. The central porch extends over the windows to provide weather protection and a strongly horizontal element. It features pairs of timber posts on the corners and a curvilinear timber valance across the front. At the rear of the site is an outbuilding of the same period. The front fence is original horizontal timbers and is appropriate to the Bungalow style of the house and its garden setting. The dark brown colour of the house may be the original colour scheme.
