This sheet should be read in conjunction with Graeme Butler & Associates, *Geelong City Urban Conservation Study*, Vol. 1-S, 1991.

South Geelong School No 2143 **200 Yarra Street**

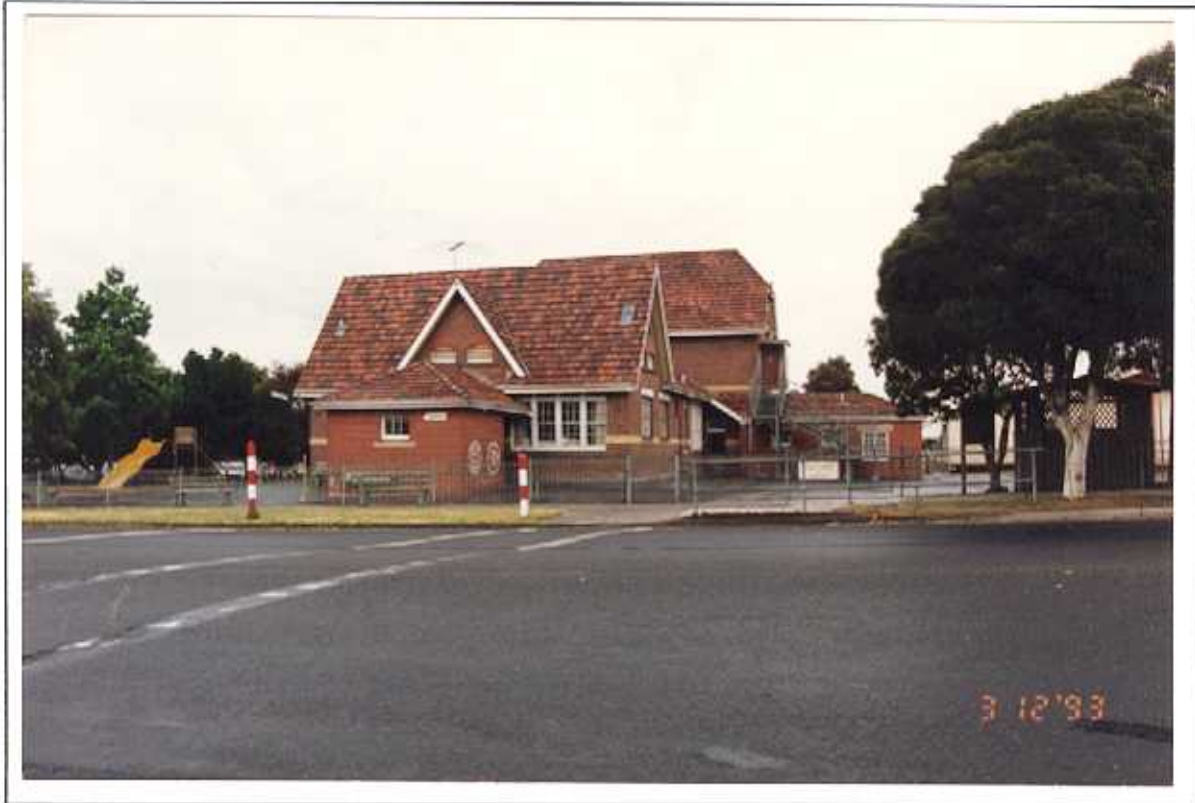
The South Geelong School is a single and double storey collection of brick buildings. The main feature of the double storey building is a large gable roof hipped above the attic storey window and clad with terracotta tiles. The roof cladding is a feature of the 1920 alterations, probably replacing a slate roof. Later red brick extensions have been added to the main structure, and although they are constructed from similar materials, they detract from the form of the original buildings. The Victorian form is also difficult to see because of the removal of verandahs from the buildings. Typical Bungalow details feature on the windows, including groups of casement windows with small panes, flat brick arches over the windows, and prominent lintels and sills. These alterations probably replaced individual rectangular windows which would have allowed less light into the classrooms. The building has a Picturesque quality due to the different roof forms and the variety of window openings. On the south facade the attic storey casement window is notable, as is the bell tower that is positioned on the ridge of the roof joining the two main building forms.
