# STORIC PLACES DOCUMENTATION SHEET

Geelong Regional Commission

Sheet 290

PLACE NAME: FORMER HARP INN  
LOCAL GOVERNMENT AREA: CITY OF GEELONG WEST

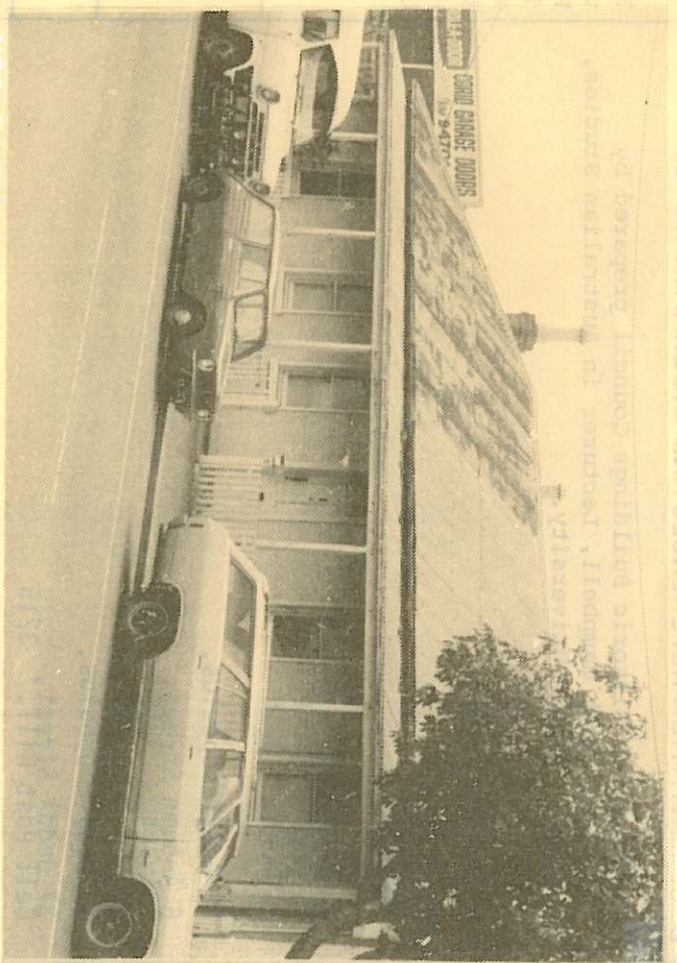
The former Harp Inn was an important public house from a very early era located strategically on the Old Melbourne Road opposite the adjoining Sale Yards and stockyards. It is an unpretentious solid brick building with double hipped roof. Some Morewood & Rogers roof tiles remain, however, the integrity of the building has been decreased by the alteration to the windows. An important early hotel in Geelong.

RECOMMENDATIONS: PROTECTIVE MEASURES

Geelong Regional Commission Register  
Australian Heritage Commission Register of the  
National Estate  
Historic Buildings Council Register
