**BELMONT HERITAGE REPORT (INDIVIDUAL CITATIONS)**  
**(FORMERLY PART OF THE GREATER GEELONG OUTER AREAS HERITAGE STUDY STAGE 2)**

Site Address	No.	Street/Site Name	Town/Suburb	Postcode
	10	Evans Street	Belmont	3216
			Site Name	House

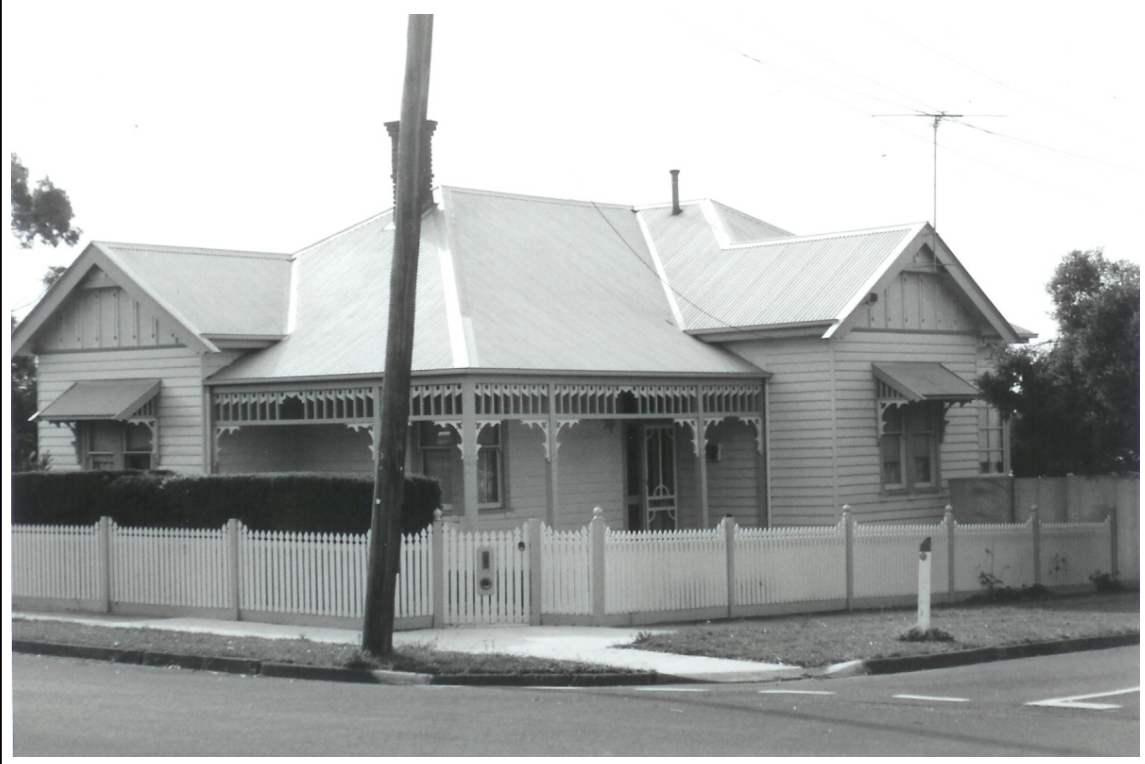
The asymmetrical, single storey weatherboard Federation style house is characterised by a central, dominant hipped roof form, together with gable and hipped roofs that project to the sides, and a recessed return verandah under the main roof. These roof forms appear to be clad in corrugated colorbond. An early, tall corbelled brick chimney adorns the roofline. Wide overhangs are a feature of the eaves. The early timber framed double hung windows are arranged in pairs under the gables and as single windows at the corner under the verandah. The front timber door with sidelight appears to be early.

A feature of the design is the returned verandah between the projecting gables. It is formed under the projection of the major hipped roof and is supported by recent but appropriate worked timber posts and brackets. A recent but appropriate timber fretwork valance adorns the verandah.

Early decorative features of the design include the gable stucco work - the battening is appropriate although recent.
