BELMONT HERITAGE REPORT (INDIVIDUAL CITATIONS)
(FORMERLY PART OF THE GREATER GEELONG OUTER AREAS HERITAGE STUDY STAGE 2)

TECHNICAL SHEET

Site Address	No.	Street/Site Name	Town/Suburb	Postcode
	99	Francis Street	Belmont	3216
			Site Name	House

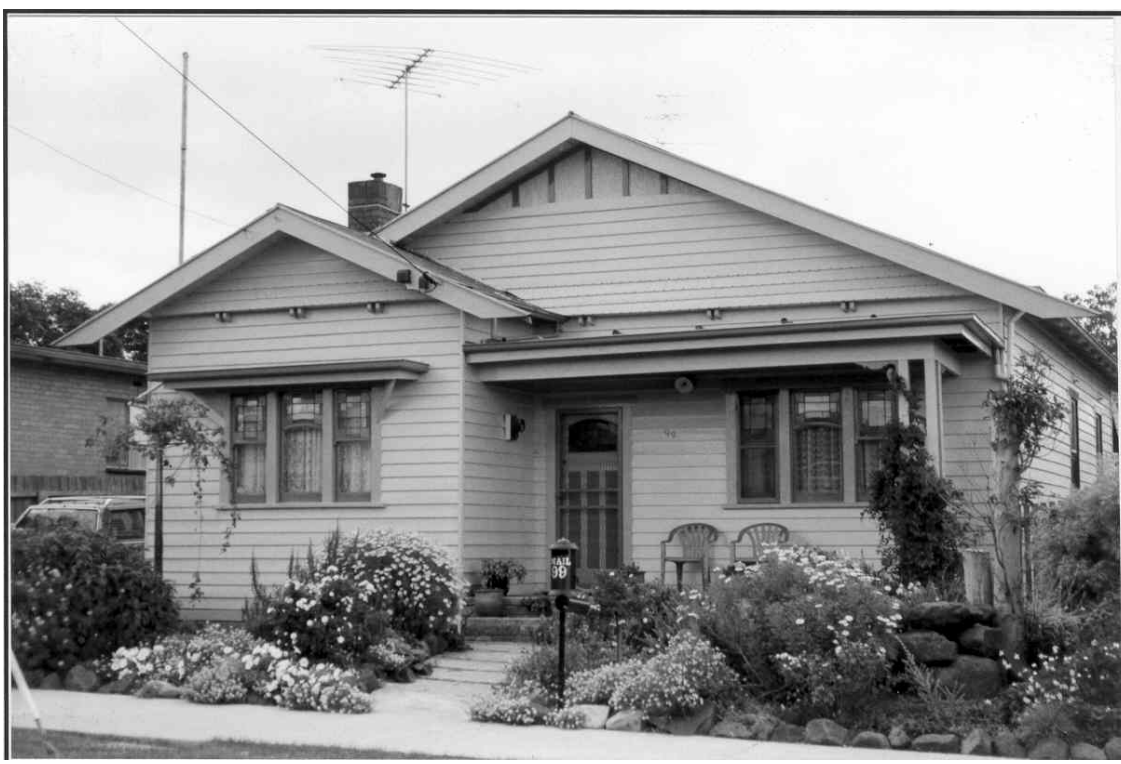
The asymmetrical, single storey weatherboard interwar Californian Bungalow house is characterised by a dominant gable roof form, together with a minor gable roof and a flat roofed verandah that project towards the street frontage. These roof forms are clad in galvanised corrugated iron. An early brick chimney with a soldier course capping adorns the roofline. Wide overhangs and exposed rafters are features of the eaves. The early timber framed windows are arranged in banks of three and have a wider central light with a bowed sash and side double hung windows, typical of interwar Bungalow design. The windows within the minor gable have a flat roofed window hood over, supported by plain timber brackets. The front timber and glazed door is also early.

The verandah is supported by recent? timber columns which have recent worked brackets.

Early decorative features of the design include the window leadlighting and the gable infill (brackets, shingling, stucco work and battening).
