**BELMONT HERITAGE REPORT (INDIVIDUAL CITATIONS)
(FORMERLY PART OF THE GREATER GEELONG OUTER AREAS HERITAGE STUDY STAGE 2)**

<p>Existing Use/Type Suburban Residential</p>	<p>Key Dates Original 1908-09</p>	<p>Site Address No. 86 Street/Site Name High Street</p>
<p>Survey Date 16/04/1998</p>	<p>Cons Man Plan</p>	<p>Town/Suburb Belmont Postcode 3216</p>
<p>Recorded By David Rowe</p>	<p>Precinct Name</p>	<p>Current Site Name House</p>

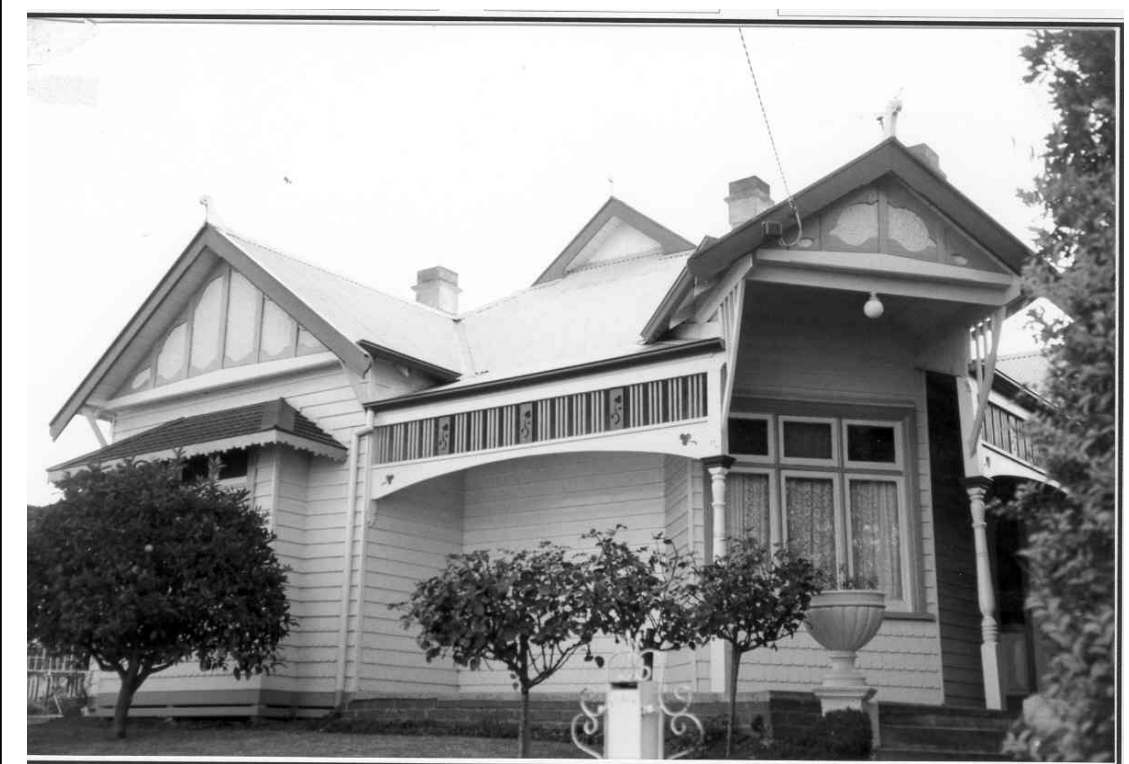
Site Address	No.	Street/Site Name	Town/Suburb	Postcode
	86	High Street	Belmont	3216
			Site Name	House
Description				
<p>The site at 86 High Street has a front setback of approximately 4 metres, and side setbacks of approximately 2 - 4 metres. These setbacks are shown on the 1928 GWST Plan of Drainage.⁴</p> <p>The asymmetrical, single storey, horizontal weatherboard Federation style house is characterised by interlocking hipped and projecting gabled galvanised corrugated iron roof forms. Early brick chimneys adorn the roofline. Wide overhangs and exposed rafters are features of the eaves. The early timber framed casement windows are arranged in banks of three on the street facade, with a notable feature being the corner windows on the chamfered diagonal. The windows under the gable project from the wall and have a window hood over (with recent? tiled cladding).</p> <p>A feature of the design is the return verandah, with its corner diagonal portico forming a welcoming entrance to the house. This entrance gable is supported by early worked timber brackets. The remainder of the verandah is supported by worked timber posts with a decorative fretwork valance.</p> <p>Apart from these verandah elements, early decorative features of the design include the four courses of timber joinery wall cladding simulating shingling near ground level, gable ridge ornaments, gable brackets and gable infill (stucco work and ornate battening).</p>
