**BELMONT HERITAGE REPORT (INDIVIDUAL CITATIONS)
(FORMERLY PART OF THE GREATER GEELONG OUTER AREAS HERITAGE STUDY STAGE 2)**

| <p>Existing Use/Type Suburban Residential</p> <p>Survey Date 16/04/1998</p> <p>Cons Man Plan </p> <p>Recorded By David Rowe</p> | <p>Key Dates Original 1923-24</p> <p>Major Changes </p> <p>Precinct Name </p> | <p>Site Address Street/Site Name Mt Pleasant Road</p> <p>No. 39</p> <p>Town/Suburb Belmont</p> <p>Postcode 3216</p> <p>Current Site Name House</p> |

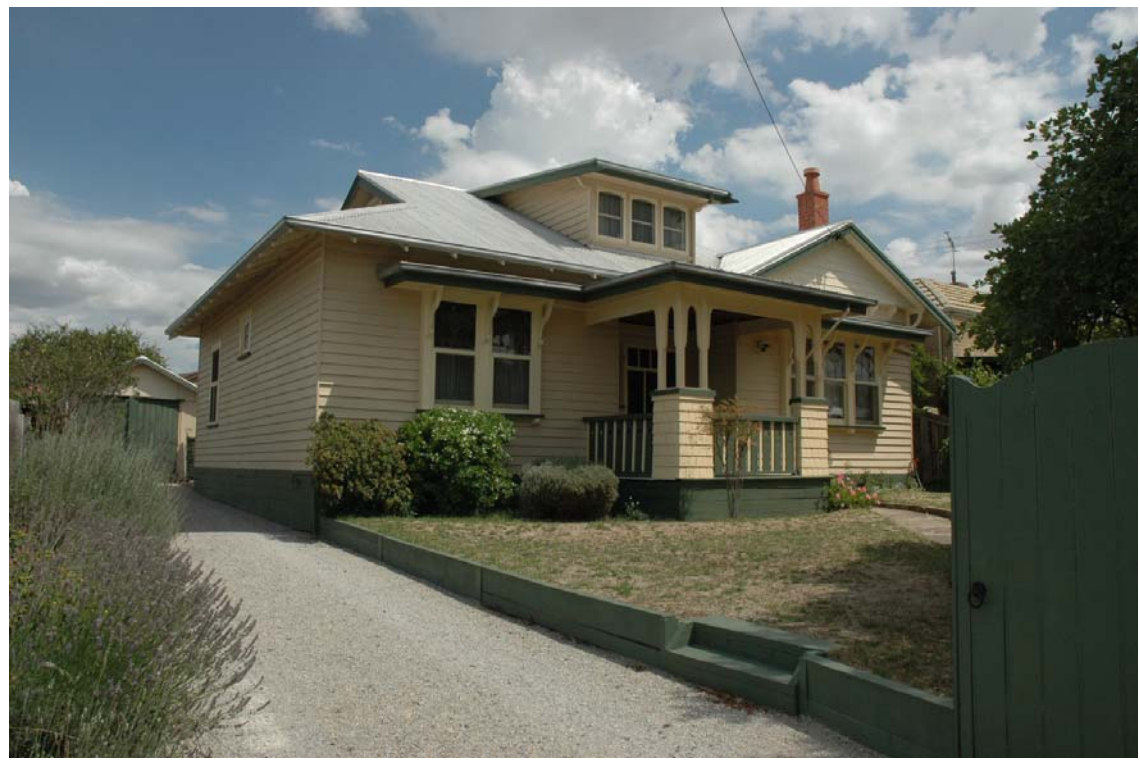
| Site Address | No. | Street/Site Name | Town/Suburb | Postcode | |
|---|---|--|---|--|--|
| <p>The site at 39 Mount Pleasant Road has visual connections with the recent flowering gum tree-lined streetscape, to the Belmont Common to the east and to the Prendegast shop to the north-west. This house is set in a streetscape formed by predominantly Edwardian and interwar Bungalow single storey homes. The house has typical front and side setbacks and a driveway along the side. These setbacks are shown on the 1927 GWST Plan of Drainage.³ An inappropriate timber paling fence (approximately 2000mm high) forms the front boundary.</p> <p>The single storey, asymmetrical weatherboard interwar Californian Bungalow house is characterised by a dominant gambrel roof form that traverses the site, together with a minor gable and flat roofed verandah that project towards the street frontage. These roof forms are clad in corrugated zincalume?. Three tall red brick chimneys (two with terra cotta pots) adorn the roofline. Wide overhangs and exposed rafters are features of the eaves. Early timber framed double hung windows, in a bank of two and three respectively, are located on the street facade. The front door also appears to be original, possibly with a sidelight.</p> <p>A feature of the design is the central, flat roofed verandah, whereby its roof extends in narrow wings to the east and west to form window hoods. The verandah is supported by worked timber posts arranged in threes, which in turn are supported by square shingled piers with a capped timber balustrade between.</p> <p>Early decorative features of the design include the worked timber window and window hood brackets, window leadlighting and the gable infill (including the brackets and shingling).</p> <p>The dormer roof and windows may be a more recent addition.</p> | | | | | |
