# FORMER KEW COTTAGES 115 PRINCESS STREET, KEW

## CONSERVATION MANAGEMENT PLAN

**B1 Cottage** (Unit 10)  
**B3 School House** (Parents Retreat/Chapel)  
**B6 Dining Room** (STAD)

FINAL REPORT

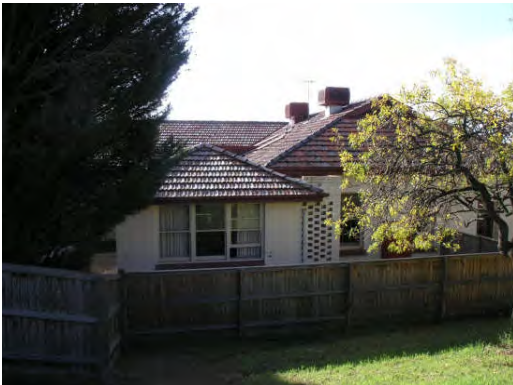
**Photograph 3:** South west elevation showing later extension to B1  
**Source:** HLCD, 22.05.07

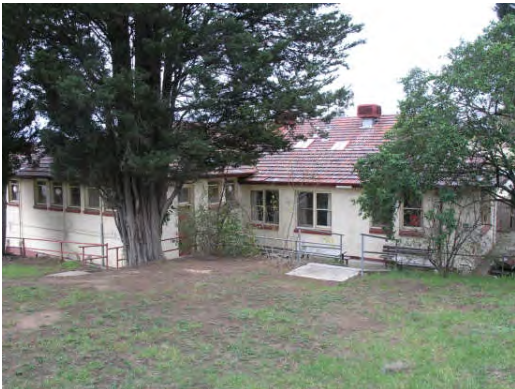
**Photograph 6:** North western elevation of B1 showing extension to original roofline  
**Source:** HLCD, 22.05.07

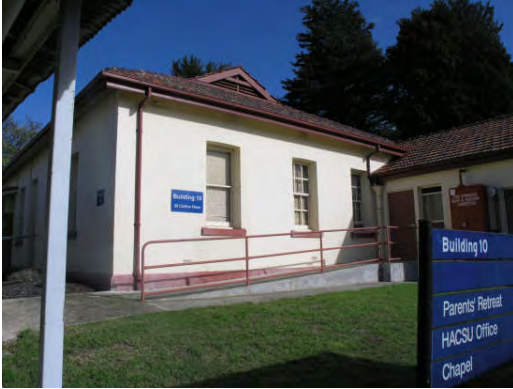
**Photograph 7:** North east elevation of B1 showing the extension to the right hand side of the original cottage  
**Source:** HLCD, 22.05.07

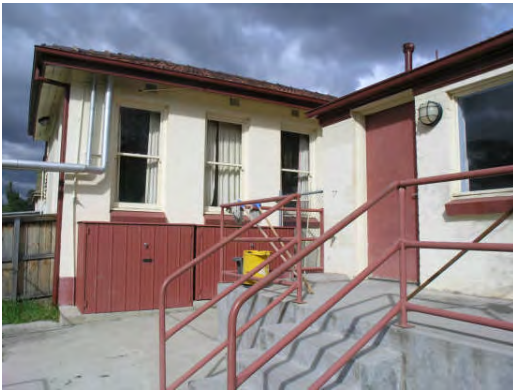
**Photograph 8:** North east elevation of B1 showing rear additions  
**Source:** HLCD, 22.05.07

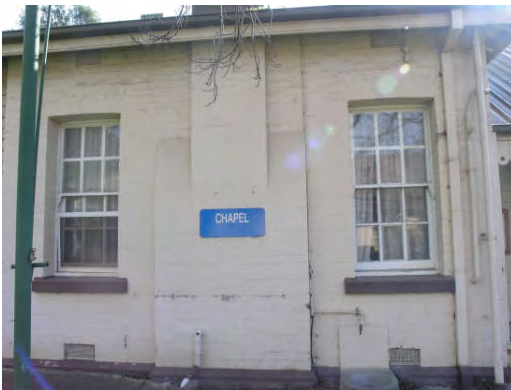
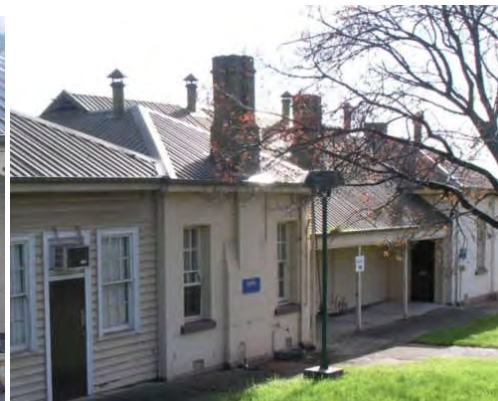
**Photograph 16 & 17:** South eastern side of B3 showing original windows and chimney stack, and the School Bell  
**Source:** HLCD, 22.05.07

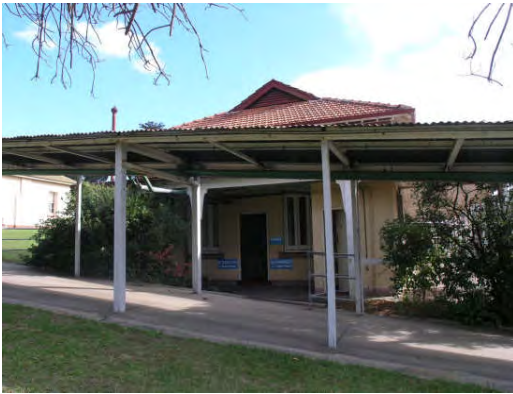
**Photograph 25:** South east elevation of B6 looking towards toilet block additions with concrete section of verandah floor  
**Source:** HLCD, 22.05.07

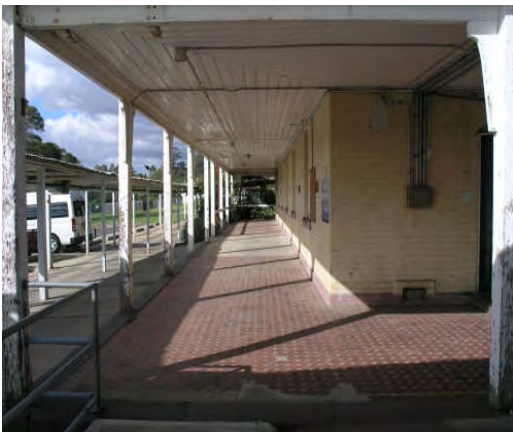
**Photograph 26:** Verandah along north eastern side of B6 showing concrete infill section  
**Source:** HLCD, 22.05.07
