**BENDIGO GOLDFIELDS HOSPITAL  
HOSPITAL  
LUCAN STREET, BENDIGO**

**SURVEY DATE: 1991-2**

**PROPOSED EXTENT: BENDIGO GOLDFIELDS HOSPITAL WINGS (EXPOSED ON WEST AND NORTH), PART PERIMETER BRICK WALL ON BAYNE STREET, IRON AND STONE FENCE TO LUCAN STREET, FOUNTAIN, AND OFFICERS' QUARTERS ON STEWART STREET (REAR OF SITE)**

**BENDIGO & EAGLEHAWK HERITAGE STUDY-SIGNIFICANT SITES  
GRAEME BUTLER & ASSOCIATES**

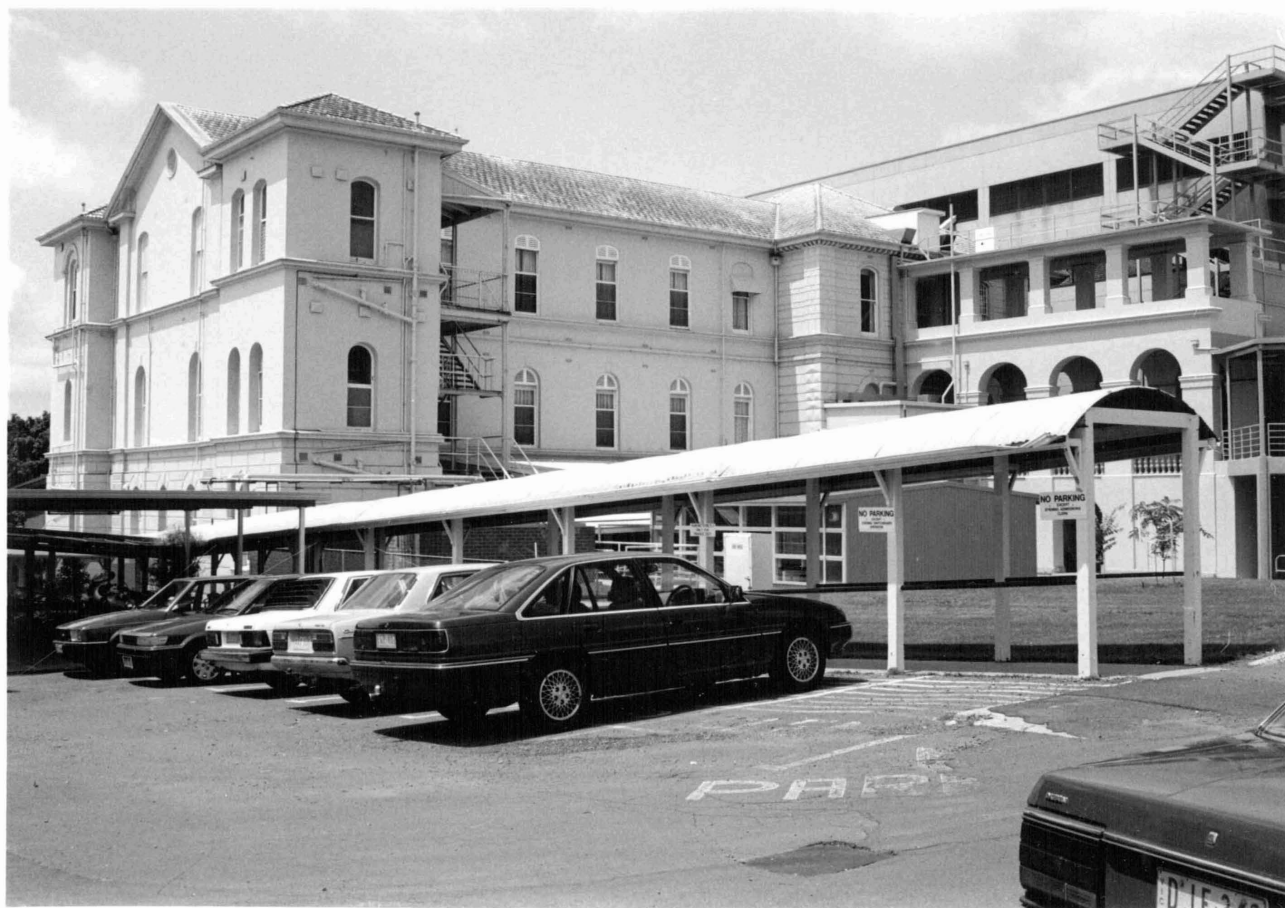
The building is of two storeys beneath a continuous hipped roof with projecting wings to each side and the centre of the building marked with a tower rising above the roof. The building achieves its power through its heaviness of the plinth, the continuous rustication and especially the repetitive and continuous lines of fenestration. The broken chord pedimented treatment of the gables to the projecting wings further emphasises the constructivist nature of its architectural concept and the design is completed by the tower which is more akin to an earlier baroque tradition, but superbly balances the weight of the composition by giving it a delicate vertical emphasis. The building is constructed of rendered brick on a sandstone footing. The slate roof has been replaced with tiles. Internally, it is very simple with a long central corridor, two staircases and smallish rooms. Little embellishment remains, although the corridor walls have an ashlar finish and the wing wards retain their pressed metal ceilings.

The centre block of the present hospital was erected in 1858, the two wings added in 1864 and the central clock tower in 1866. Clock-makers, Joseph and Company of Pall Mall, made the clock. The building gives the impression of having been designed in stages as well as erected. Now, only the western wing remains unobscured by modern additions.
