**HOUSE
237 EAGLEHAWK ROAD,**

SURVEY DATE: 1991-2

**BENDIGO & EAGLEHAWK HERITAGE STUDY-SIGNIFICANT SITES
GRAEME BUTLER & ASSOCIATES**

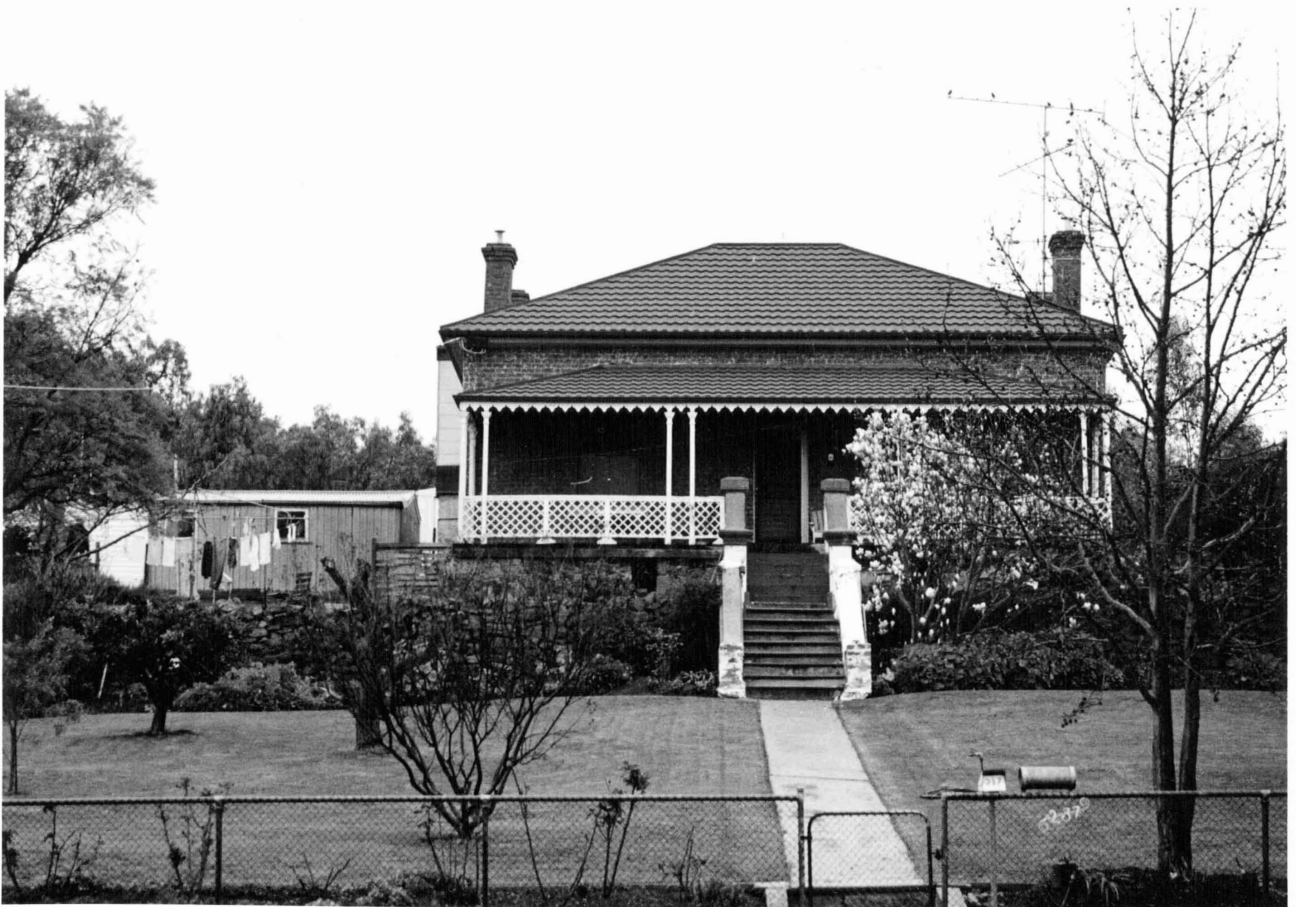
Faced with Flemish-bonded red brick (9"?), this house is constructed substantially from random rubble freestone, with red brick also used for the three visible corbel-top chimneys and as a border to side-wall openings. The high simply-hipped roof line is also typical of early houses, together with a simple skillion roof at the rear over service rooms. A 1950s plan shows six main rooms and what appears to have been a detached kitchen, scullery and servants room in a proposal to convert the house to two flats¹.

The original hipped and concave line of the verandah roof line is also still visible, despite recent recladding with bituminous covered aluminium tiles. A scalloped timber verandah frieze also appears original, stretching between coupled timber posts with built-up capitals. Although possibly not the original balustrading, the lattice-work is related to the house construction period. Rubble stonework supports the verandah and a grand stair, constructed from brick and stucco, piered and with a mid-landing, descends to the lower lawn.

New unrelated cladding has been added to the main and verandah roof and the eaves rebuilt. What may have been a stone detached kitchen or service wing at the rear has been rendered, its chimney part demolished and a cement-sheet clad storey added.

The front fence has been replaced in chain wire and a security door added. A ruinous stone wall is on the north side of the house.
