**COLONIAL BANK,
BANK
32 PALL MALL,**

SURVEY DATE: 1991-2

**BENDIGO & EAGLEHAWK HERITAGE STUDY-SIGNIFICANT SITES
GRAEME BUTLER & ASSOCIATES**

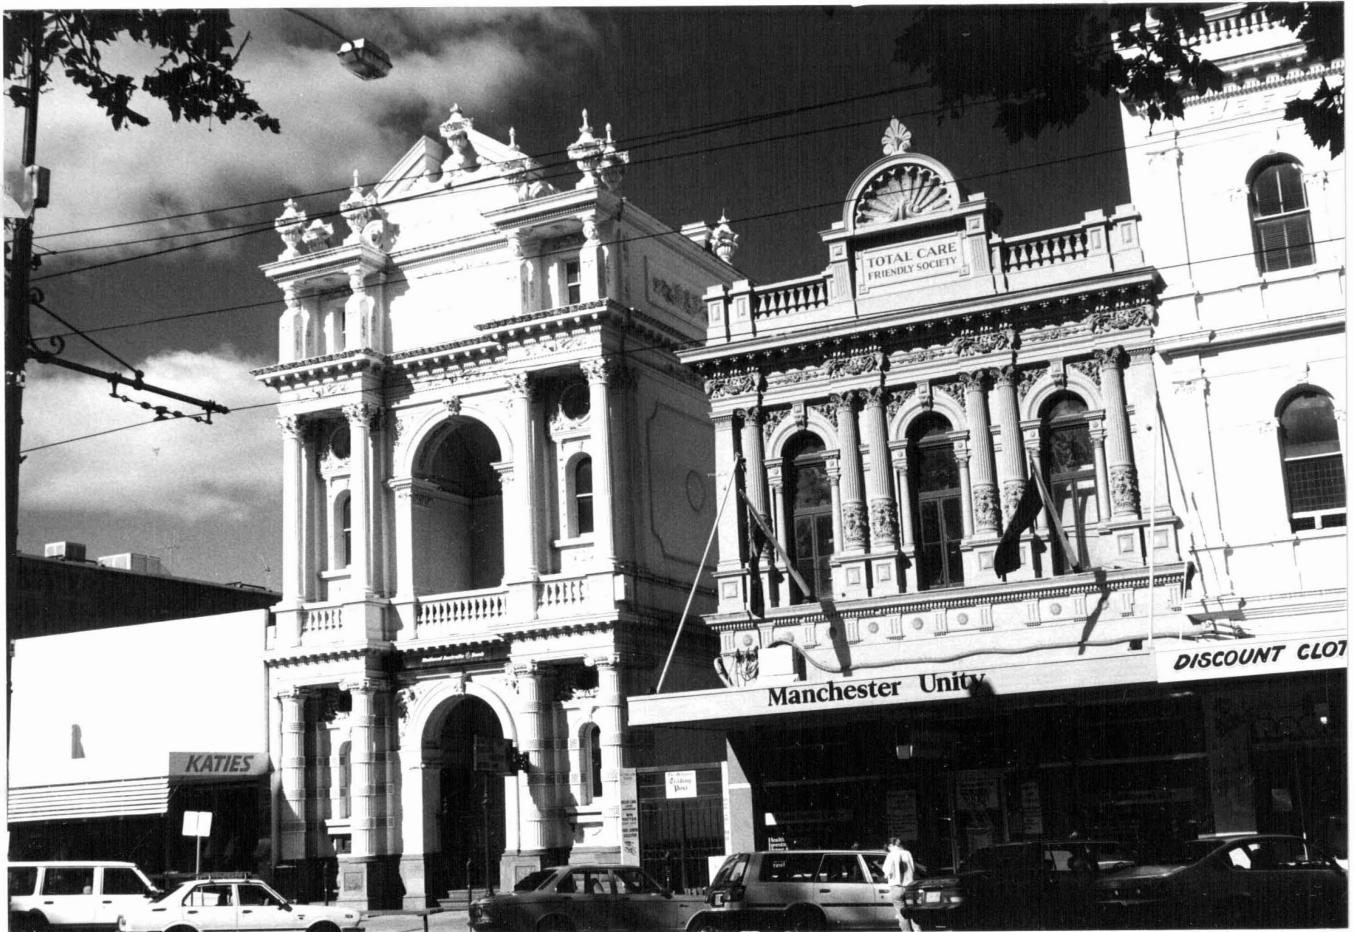
No. 32 Pall Mall, Bendigo, is a three-storey building with a central archway and matching windows at street level, repeated at first floor level and a third attic type floor above this again, all surmounted by a heavy cornice. The banking chamber is beyond and extends upwards of two floors to a fine ceiling. Beyond this again are bachelor quarters of two floors and ancillary store rooms.

The central archway entrance has been defaced in recent years by making a side entrance through an anteroom. Modern light fittings have also marred Vahland's lofty vault. An inner arched doorway to the rear sections has received unsympathetic treatment.

The premises are in excellent repair.
