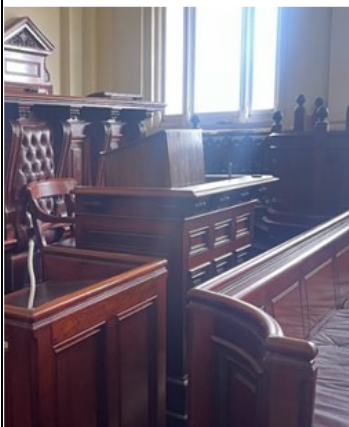
| Image | <p><i>2025. Associate's desk in Supreme Court.</i></p> |
| Description | Cedar desk with screens. Some additions have been made to accommodate use, such as removal of the original fixed bench in favour of a loose chair. Upholstery behind, indicative of original fixed bench location, has been retained. |
| Condition | Very good condition. |

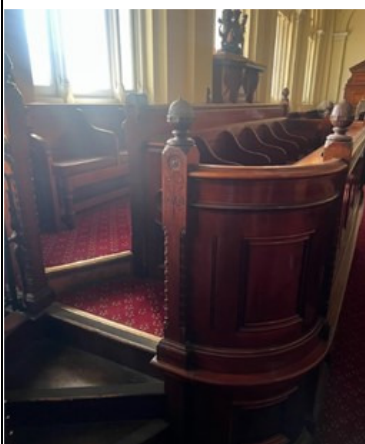
| Object identification | Jury Box |

| Image | <p><i>2025. Jury box in Supreme Court.</i></p> |
| Description | Made from cedar, the design of the jury box was prepared by the Public Works Department in 1894 and contracted to the firm John Bennett and Sons. The location of the jury box and the reporters' box |

| | was swapped shortly after the opening of the building. At this time the location of the entrance to the jury box was swapped. |
| Condition | Very good condition. |

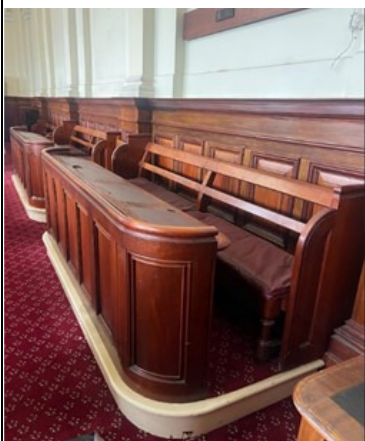
| Object identification | Reporters' seats and desks (two of each) |

| Image | <p><a href="#">2025. Reporters' seats and desks in Supreme Court.</a></p> |
| Description | Made from cedar, the design of the jury box was prepared by the Public Works Department in 1894 and contracted to the firm John Bennett and Sons. The location of the reporters' box and the jury box was swapped shortly after the opening of the building. |
| Condition | Very good condition. |

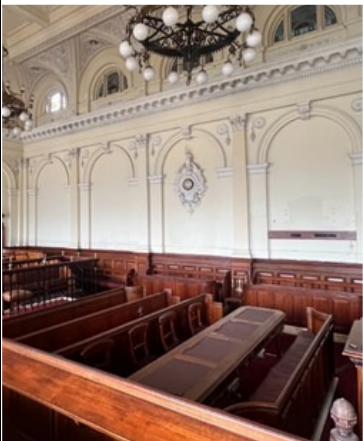
| Object identification | Barristers' and solicitors' seats and tables (2 panelled benches with writing slope on back, 2 panelled benches with curved corners, 1 long desk with four leather insets) |

| Image | <p>2025. Barristers' and solicitors' seats and tables.</p> |
| Description | Located on a raised platform and made from cedar with upholstered cushions to bench seats. The first row from the judge's bench is a long-seated bench with its back to the judge, the second row has loose chairs (the ones presently in the courtroom are not documented as part of the original fitout and have therefore not been included), the third and fourth rows are fixed benches with writing slopes attached to the bench in front for instructing solicitors and other counsel. |
| Condition | Very good condition. |

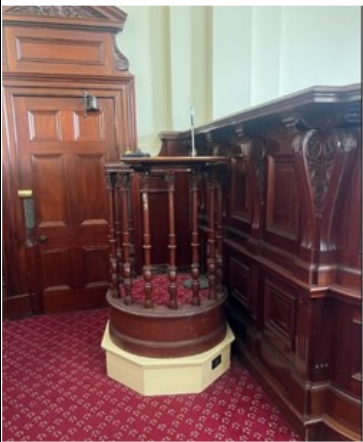
| Object identification | Witness box |

| Image | <p>2025. Witness box.</p> |

| Description | Witness box made from cedar and documented in the original PWD fit-out drawings. This is not the original location of the witness box, and alterations include a platform that was introduced to raise the height of the witness at an unknown date. |
| Markings | Some graffiti to the surface of the writing slope. |
| Condition | Very good condition. |

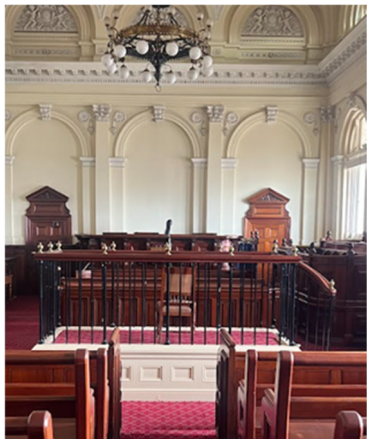
| Object identification | Prisoner's dock |

| Image | <p>2025. Prisoner's dock.</p> |
| Description | The prisoner's dock remains in its originally documented position and retains all original features except for the gate. The base of the dock has the same panelling and moulding as the other fittings in the Supreme Court. |
| Condition | Very good condition. |

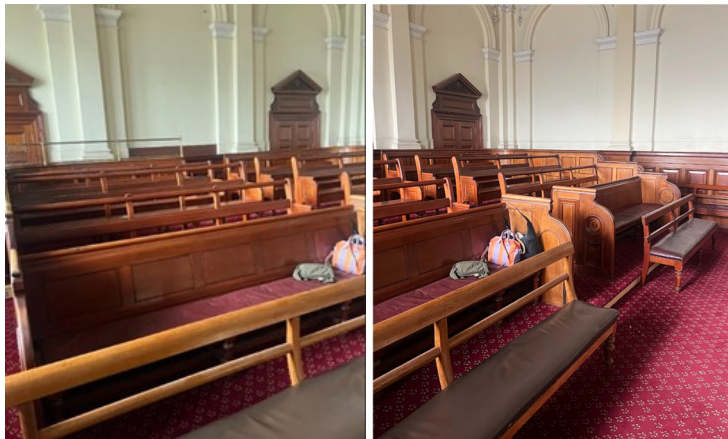
| Object identification | Public gallery |

| Image | <p>2025. Public gallery.</p> |
| Description | Stepped public gallery with five tiers of fixed benches and surrounding screen. |
| Condition | Very good condition. |

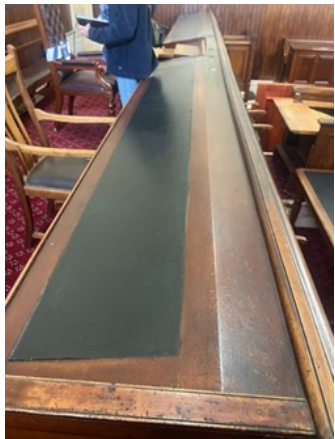
| Object identification | Judge's bench |

| Image | <p>2025. Judge's bench.</p> |
| Description | Judge's bench in Magistrate's Court was part of the documented furnishings. A long bench with screen in front and writing slope behind. Made from Oregon timber with leather/vinyl inset. |

| Condition | Very good condition. |

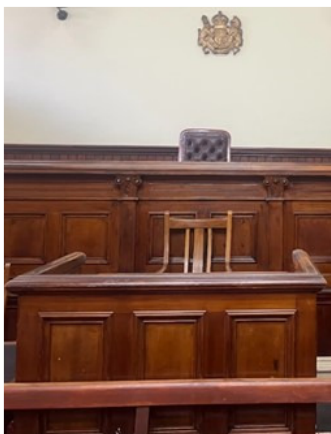
| Image | <p>2025. Clerk's desk.</p> |
| Description | Clerk's desk was part of the documented furnishings. Comprised of big timber screens to three sides with desk concealed behind. Made out of Oregon timber. The desk surface appears to have been upgraded at some point. This alteration is not visible from the front and may be reversible. |
| Condition | Very good condition. |

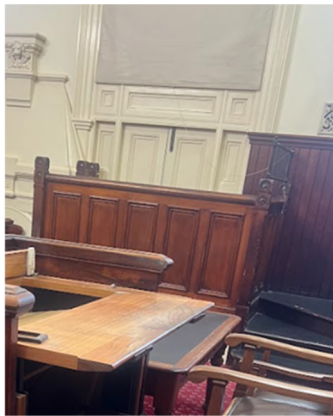
| Object identification | Prisoner's dock |

| Image | <p>2025. Prisoner's dock.</p> |
| Description | Prisoner's dock made from same timber as other furnishings in the Magistrates' Court. Metal grate on the right side of the dock looks to have been added later. |
| Condition | Very good condition. |

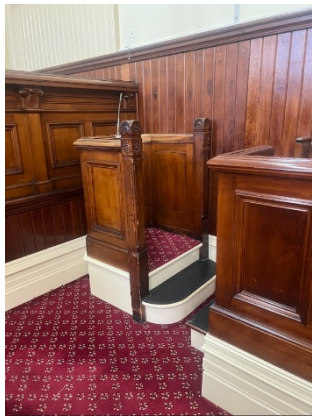
| Image | <p>2025. Witness box.</p> |
| Description | The witness box is made from the same timber with same panelling and floral motifs as the other courtroom furniture. It was documented in the original fit-out of the magistrate's court, though its position has been rearranged to accommodate the introduction of later furniture. |

| Condition | Very good condition. |

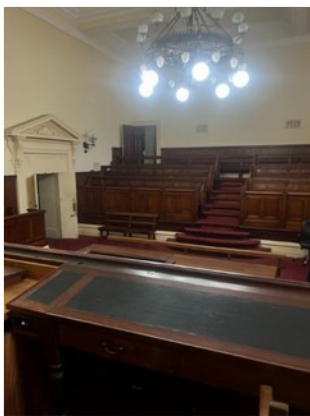
| Object identification | Public gallery including benches and front panel |

| Image | <p><i>2025. Public gallery.</i></p> |
| Description | Four tiered public gallery with timber screens to the front, designed in the same style as the other furniture in this courtroom. |
| Condition | Very good condition. |
