NEWTOWN URBAN CONSERVATION STUDY. - 'C' CITATIONS. Ref: 56

Richard Peterson Architect & Conservation Consultant. Daniel Catrice Historian 1996.

ADDRESS: 25 Buckland Avenue.

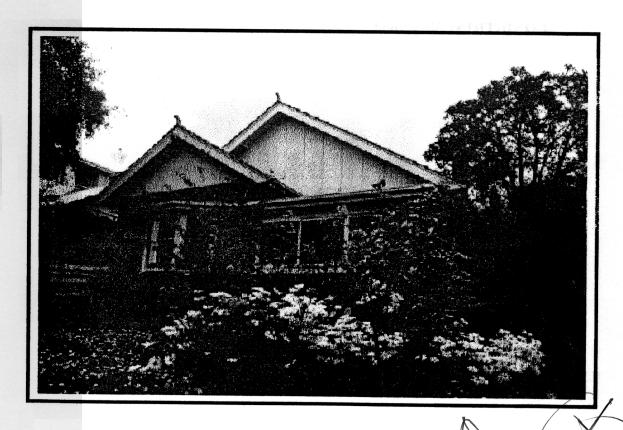
NEGS: 2.35

VISUAL DESCRIPTION: A timber, double-fronted Californian Bungalow, with a broad gable-roof facing, with Marseilles pattern unglazed terra-cotta tiles. There are four minor gables: at centre right side, right front, centre front and left side, front. These are supported on ogee timber brackets, with rectangular louvred vents and shingles, over small, convex triple brackets. Beneath right front, is a bow window with a skillion hood, with its soffit clad with shingles. Windows have leadlight upper sashes.

The centre gable is over the verandah, with a large round arch, decorated with tuckpointed, red header bricks and with battered sides. The verandah extends around the left side, under the fourth gable, with a rendered balustrade and decorated tuckpointed brick piers. Rafters are exposed.

INTACTNESS: Very good. The high brick fence is not appropriate.

CONDITION: Very good.
